ATLANTIC DIVISION
NORFOLK, VIRGINIA

Contract No. N62470-99-D-3251
High Antenna Tower System Inspection

Tower Inspection Report
600' Guyed Tower No. 2637
Grindavik Transmitter Site, Iceland
Inspection Date: 31 July and 2 Aug 2001

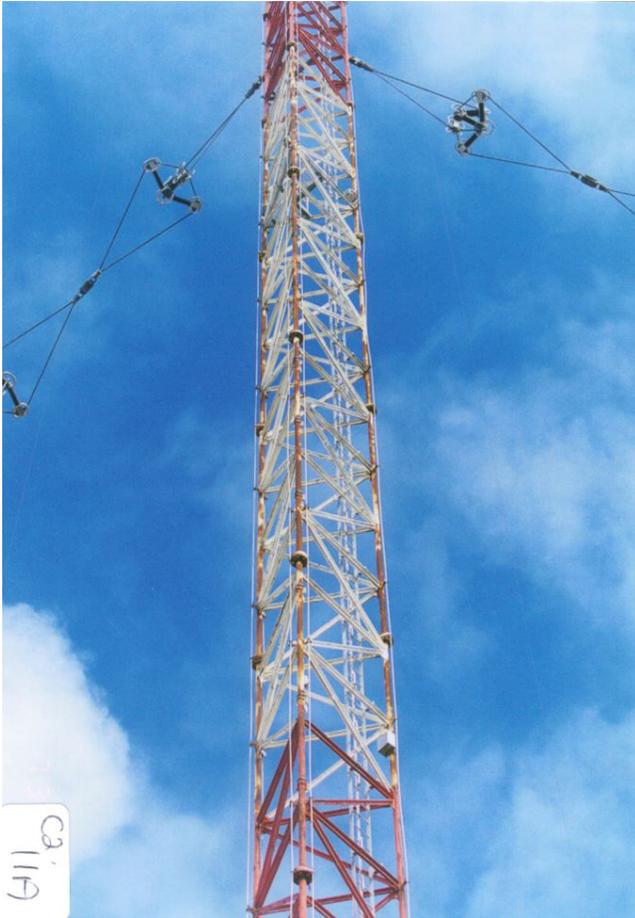
Photo No. 2

Photos No. 2-4 show the poor condition of the paint in the first, second and third white color bands, respectively. Inspectors estimated 20% of the paint was missing on the lacing members and 85% missing on the tower legs. The legs were rusty throughout the tower. Because of the deteriorated paint coverage, the tower is no longer conspicuously marked for aircraft during daylight hours. The tower should be cleaned and painted within one year.

- 2) Mechanically clean rusty areas and paint the entire tower (Photos No. 2-4, 14, 16-19, 21, 27, 29, 33).
- 3) Install new ground jumper on Column B (Photo No. 10).

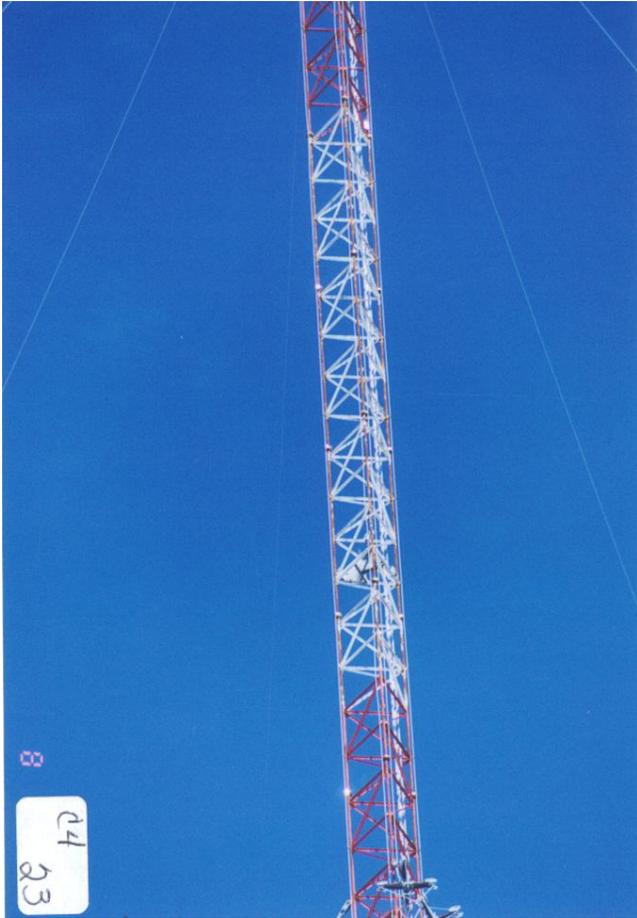
Photo No. 4

Photos No. 2-4 show the poor condition of the paint in the first, second and third white color bands, respectively. Inspectors estimated 20% of the paint was missing on the lacing members and 85% missing on the tower legs. The legs were rusty throughout the tower. Because of the deteriorated paint coverage, the tower is no longer conspicuously marked for aircraft during daylight hours. The tower should be cleaned and painted within one year. Photo No. 5 is an overall view of the tower base area.

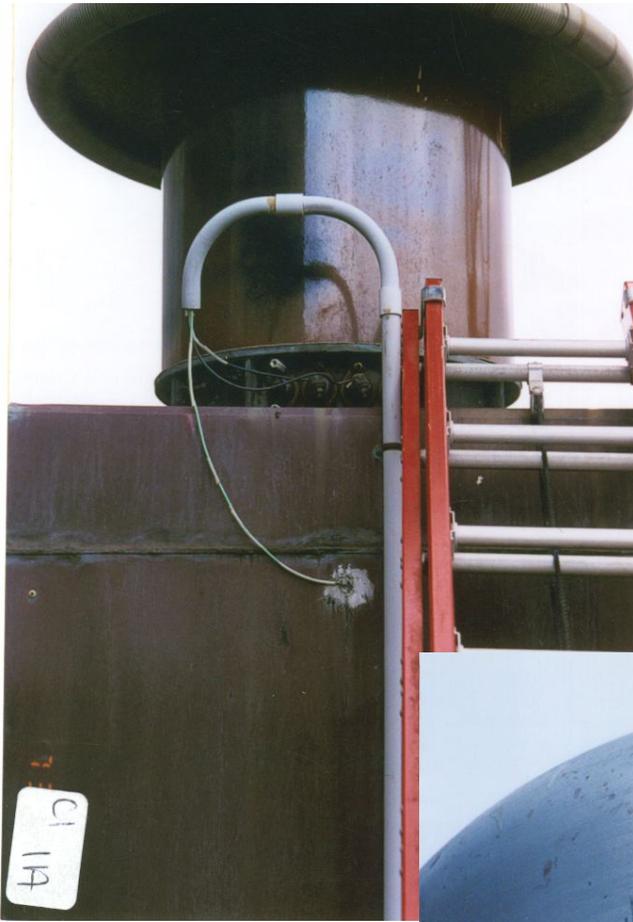
Photo No. 6 shows the incoming power supply to the isolation transformer. Inspectors measured the terminals as 118V each, totaling 236V. A broken oil gauge on the isolation transformer prevented the inspectors from checking the oil level in the transformer (Photo No. 7). The transformer should be replaced within one year.

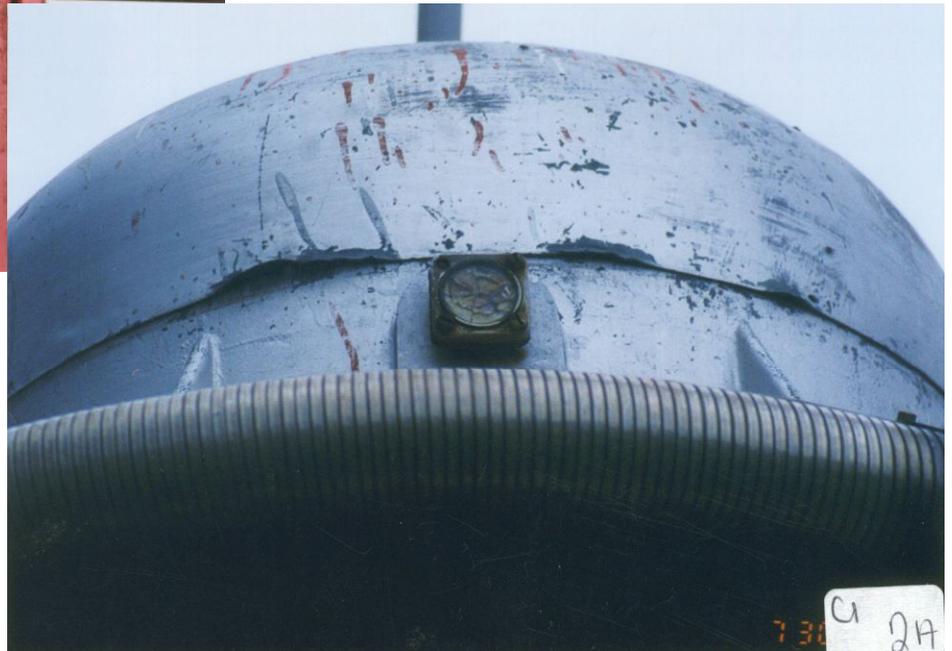
Photo No. 7

however, the oil gauge was broken (Photo No. 7). The transformer was not providing adequate voltage for the 240V system. The output voltage varied between 194 and 216 V. Given the transformer is 40-50 years old and replacement parts are no longer manufactured, the isolation transformer should be replaced within one year.

- 1) Replace isolation transformer. (existing transformer was manufactured by Austin Insulator - Model No. A-2490-A). Remove conduit that runs to the obstruction light control box at the base of the tower and replace with a longer run (approx. 20') that allows for a drip loop. Connect conduit with proper weatherproof fittings (Photo No. 11). Replace tower lighting wiring and conduit throughout the tower. Remount steady burning lights (6 total) to the outside of the tower legs to provide a more unobstructed view of the lights by approaching aircraft (Photo No. 19). Steady burning lights are Alstom ZA760. Install photocell control for lighting system.

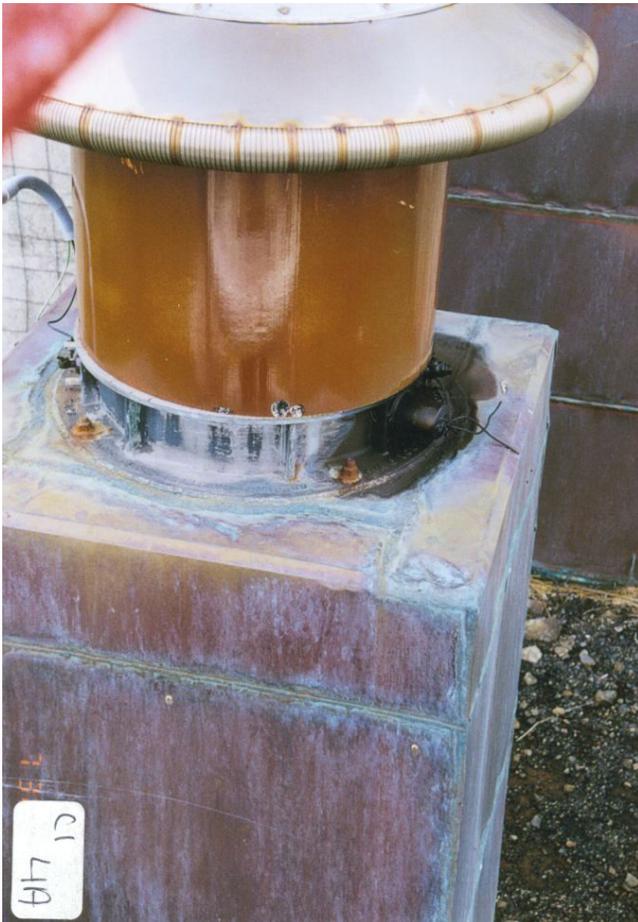
The obstruction lights are powered through an isolation transformer manufactured by Austin Insulators Model No. A-2490-A. Inspectors noted a small oil leak at the base of the transformer (Photo No. 8). Normally, this condition would call for the oil level to be checked periodically,

Photo No. 8 reveals a small oil leak at the base of the isolation transformer. Normally, the inspectors would check the oil level of the transformer, however the oil gauge was broken (Photo No. 7). The transformer was not providing adequate voltage for the 240V system. The output voltage varied between 194 and 216 V. Given the transformer is 40-50 years old and replacement parts are no longer manufactured, the isolation transformer should be replaced within one year. Photo No. 9 shows the feed thru bushing in satisfactory condition.

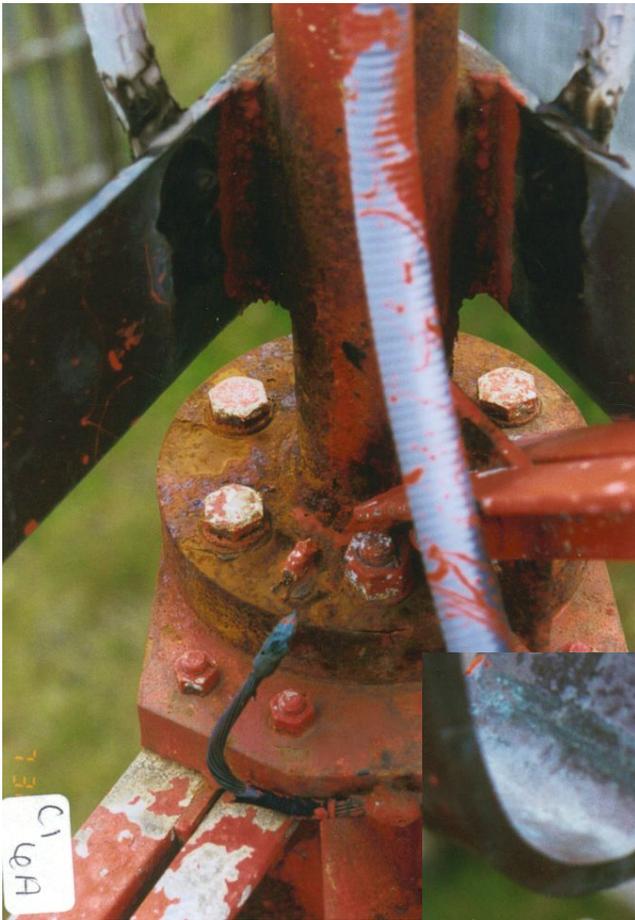
Photo No. 10

MISCELLANEOUS — Column B ground jumper near the 13' level was broken (Photo No. 10). A new ground jumper should be installed within one year. Inspectors noted the base insulator was dirty. Local forces should increase the frequency of cleaning of this insulator so dirt and salt

Column B ground jumper near the 13' level was broken (Photo No. 10). A new ground jumper should be installed within one year. Photo No. 11 shows a corroded conduit connection that was connected with zip ties. The conduit should be removed and replaced with a longer run that allows for a drip loop and connected with proper weatherproof fittings within one year.

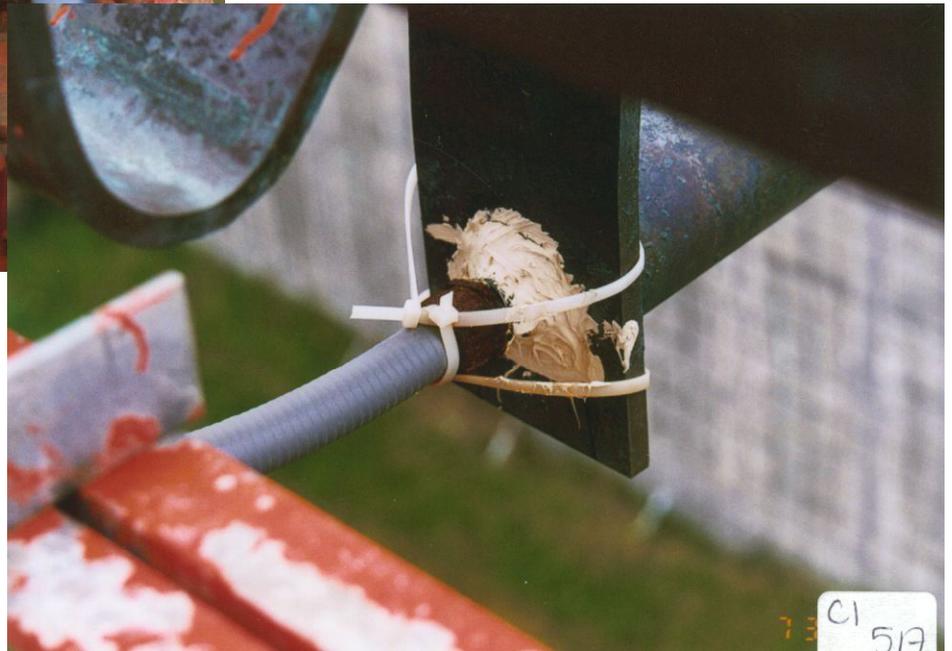
Photo No. 11

Obstruction light control box conduit was connected with zip ties (Photo No. 11) near the base. The conduit should be removed and replaced with a longer run that allows for a drip loop and connected with proper weatherproof fittings within one year.

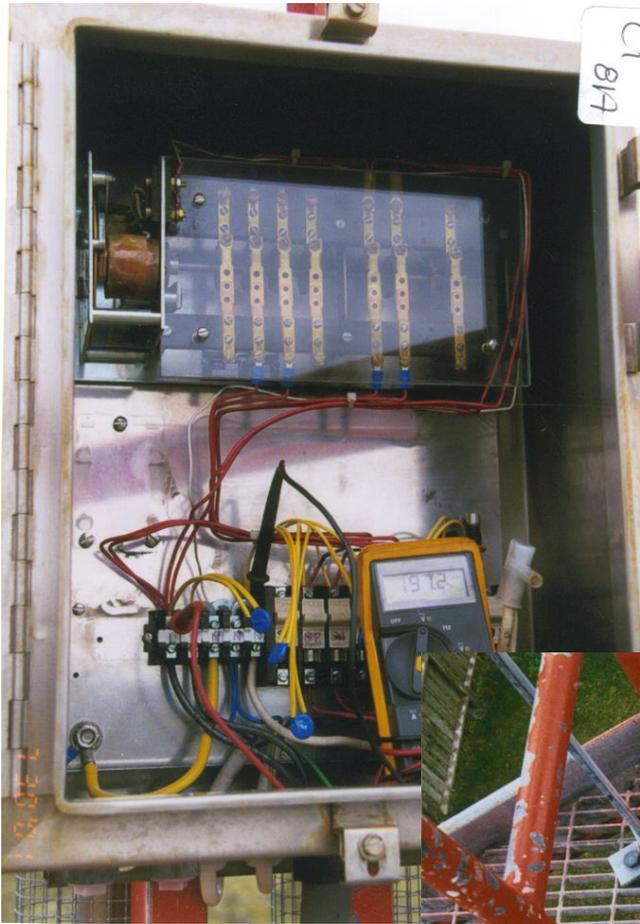
Photo No. 12

The incoming voltage at the light control box varied between 194 and 216 V. The lighting control box was in good condition at the 13' level (Photo No. 12). The platform at the 13' level (top of the tapered section) was not equipped with ladderway opening protection (Photo No. 13). Installation of ladderway opening protection would bring the platform into compliance with OSHA standards.

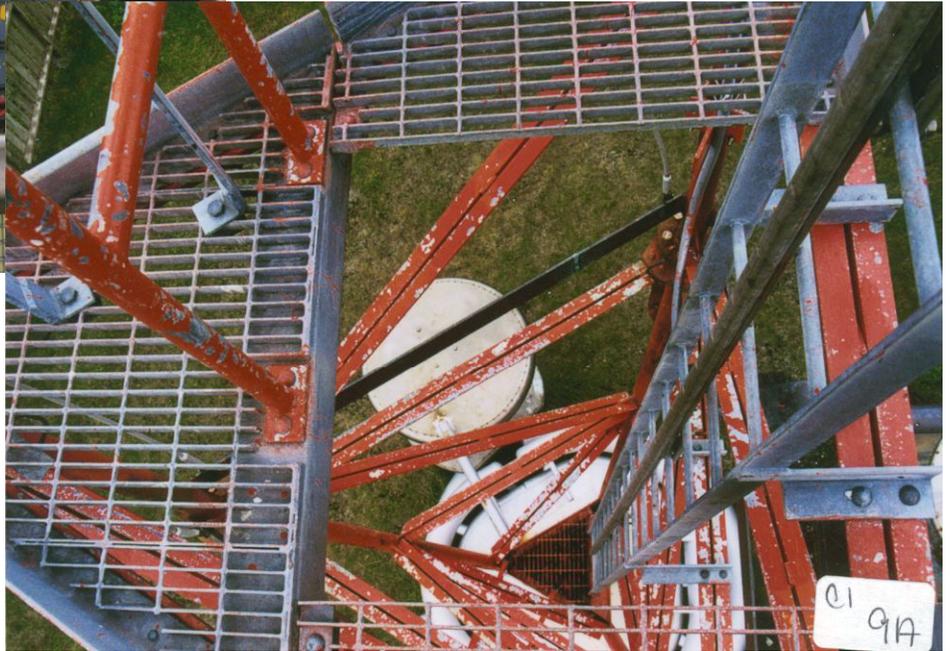
Photo No. 13

OSHA STANDARDS — As stated previously in the July 1995 Inspection Report, none of the platforms were equipped with ladderway opening protection (Photo No. 13 and 36) and only the top platform was enclosed by railing. The installation of ladderway opening protection¹ and standard railing² at all platforms would be necessary to comply with OSHA standards. OSHA standards require a minimum 30" ladder climbing side clearance³ and 7" back side clearance⁴. The ladder up the tower did not conform to these requirements. Possible solutions to ladder clearance problems include relocating the ladder to the outside of the tower or installing brackets to stand-off the ladder further from supporting members and attain additional back side clearance. Moving the ladder to the outside of the tower may not be practical because of interference from guy components. The installation of stand-off brackets may solve the backside ladder clearance deficiency but result in a climbing side deficiency. The ladder deficiencies were minor, created a very minor a safety hazard, and would be costly to correct. An analysis may determine that the costs of correcting the deficiencies out-weigh the benefits derived.

- 1) Install ladderway opening protection at the 13' level and top level platform (Photos No. 13 and 36).

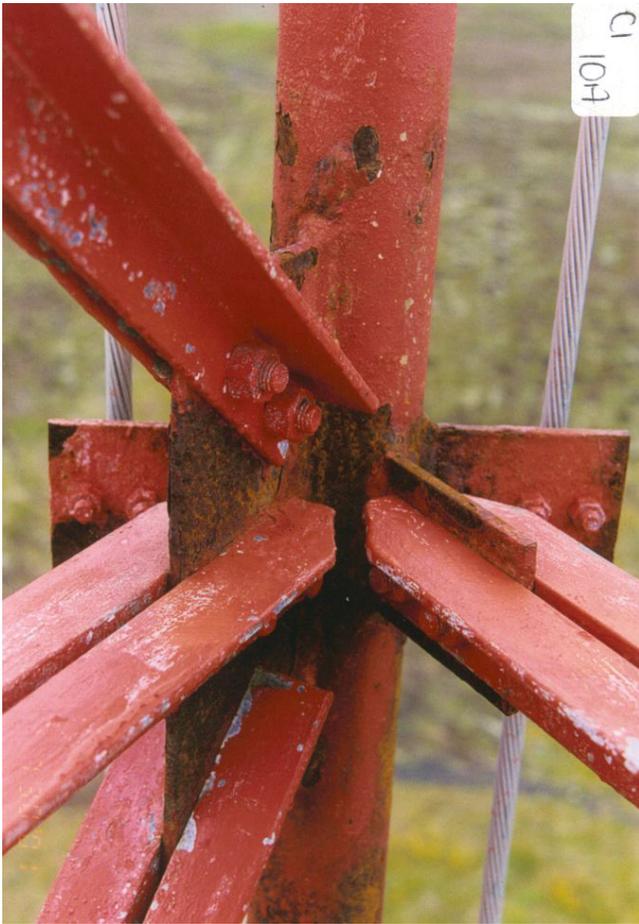
Photo No. 14 and 15 reveals typical corrosion at a gusset plate and band supporting riser wires, respectively, on Column A near the 40' level. The tower should be mechanically cleaned and painted within one year. Rusty riser wire restraining bands should be replaced within one year.

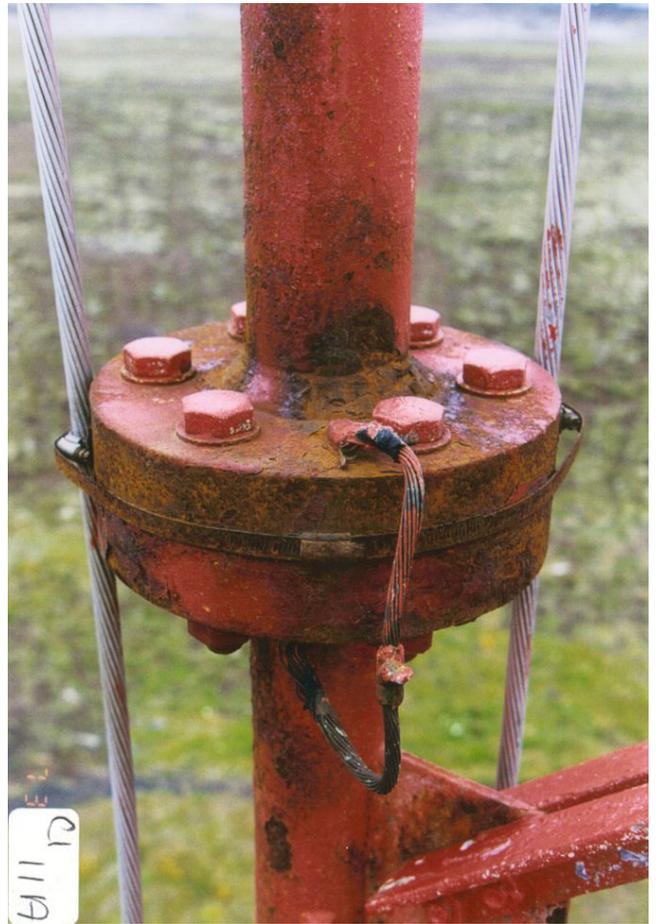
Photo No. 15

ANTENNA SYSTEM — Rusty bands supporting riser wires at each leg splice (Photos No. 15 and 21) should be replaced within one year.

- 4) Replace 78 rusty bands securing riser wires to leg splice flanges (dia. approx. 11") with stainless steel bands (Photos No. 15 and 21).
- 5) Replace deflected diagonals on Face A at the 270' and 260' levels (Photos No. 24 and 25).

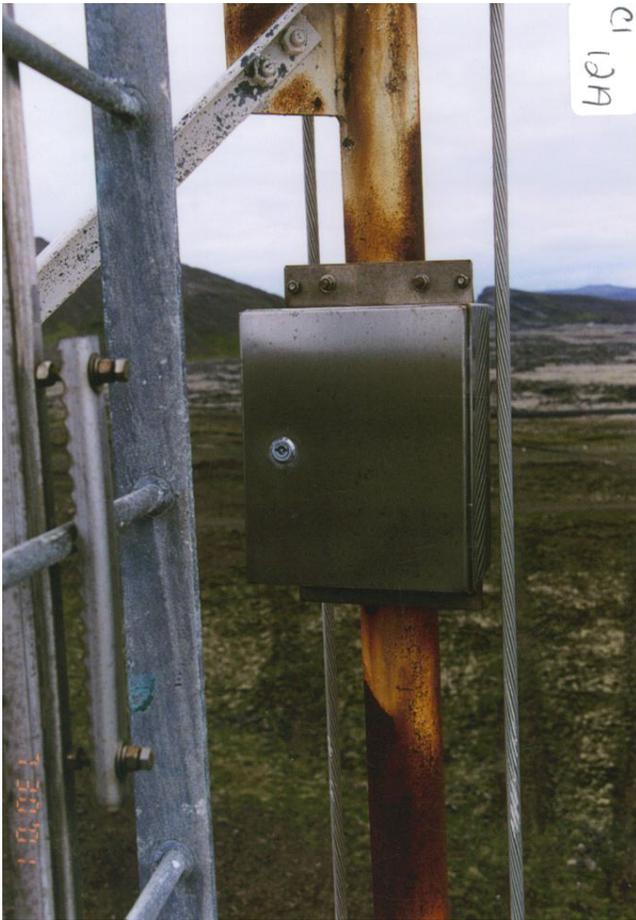
Photo No. 16

Local forces have installed stainless steel junction boxes on the tower (Photo No. 16). Photo No. 17 shows the ladder and safety rail free of corrosion and in good condition. Photos No. 16 and 17 were taken at the 90' and 110' levels, respectively, and reveal rust has replaced approximately 85% of the white paint along the tower legs. Because of the deteriorated paint coverage, the tower is no longer conspicuously marked for aircraft during daylight hours. The tower should be cleaned and painted within one year.

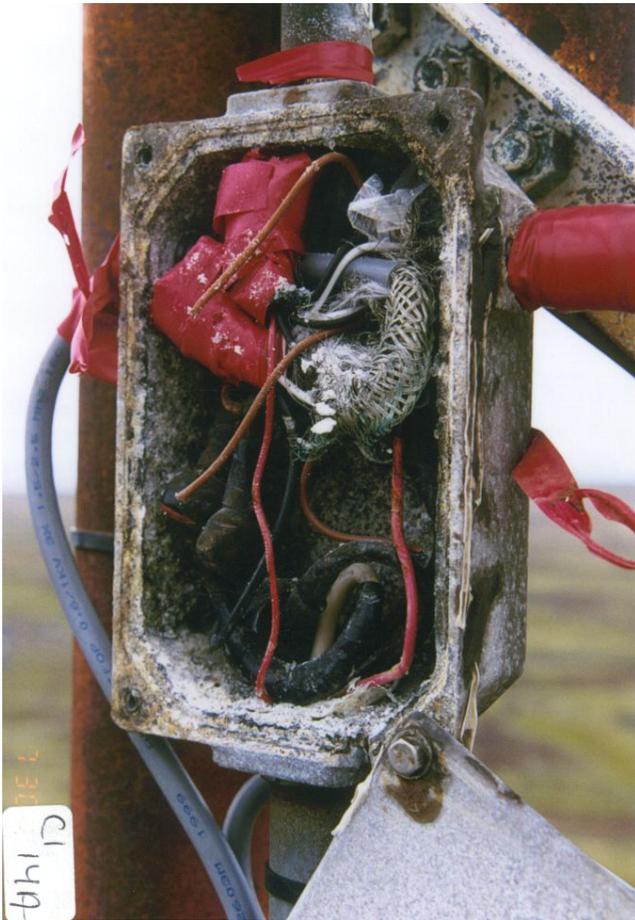
Photo No. 18

Inspectors noted all the junction boxes in use at the time of the inspection were corroded (Photo No. 18 and 31), and one box was missing a cover screw near the 380' level (Photo No. 28). The third light level steady burning lights were not in operation and faulty wiring was suspected. New wiring should be installed to this light level immediately. If necessary, temporary wiring can be installed until the planned repair of the entire lighting system can be accomplished. Local forces had installed new junction boxes (Photos No. 16 and 23).

Photo No.18 shows corrosion inside the junction box for the first steady burning light level. First level steady burning lights were mounted on the inside of the tower leg (Photo No. 19). To provide a more unobstructed view of the lights by approaching aircraft, the lights should be remounted on the outside of the tower leg within one year. Photos No. 18 and 19 show closer views of rust, typical along the tower legs. The tower should be cleaned and painted within one year.

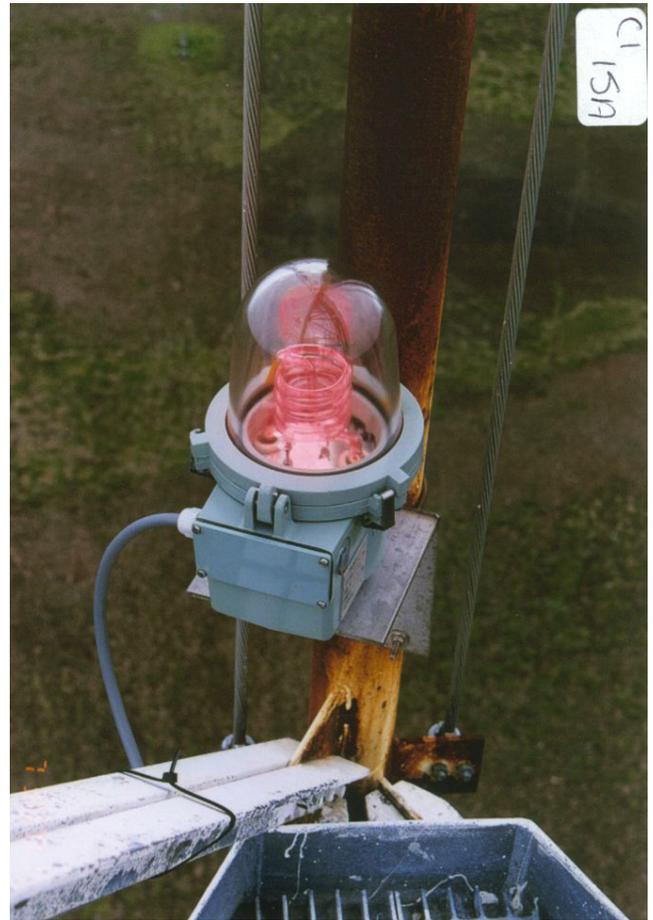
Photo No. 19

First level steady burning lights were mounted on the inside of the tower leg (Photo No. 19). To provide a more unobstructed view of the lights by approaching aircraft, the lights should be remounted on the outside of the tower leg within one year. Two of four and one of four beacon cathode tubes were not functioning at the 300' (Photo No. 26) and top level beacons (Photo No. 34), respectively. Because of these deficiencies, the mid-level beacon output was cut by 50% and the top beacon by 25%. None of the four light levels are operating properly. These towers are in a flight path and the inspectors noted many airplanes flew relatively close to the towers during the inspection. Defects with the beacons and steady burning lights have been identified in the 1995

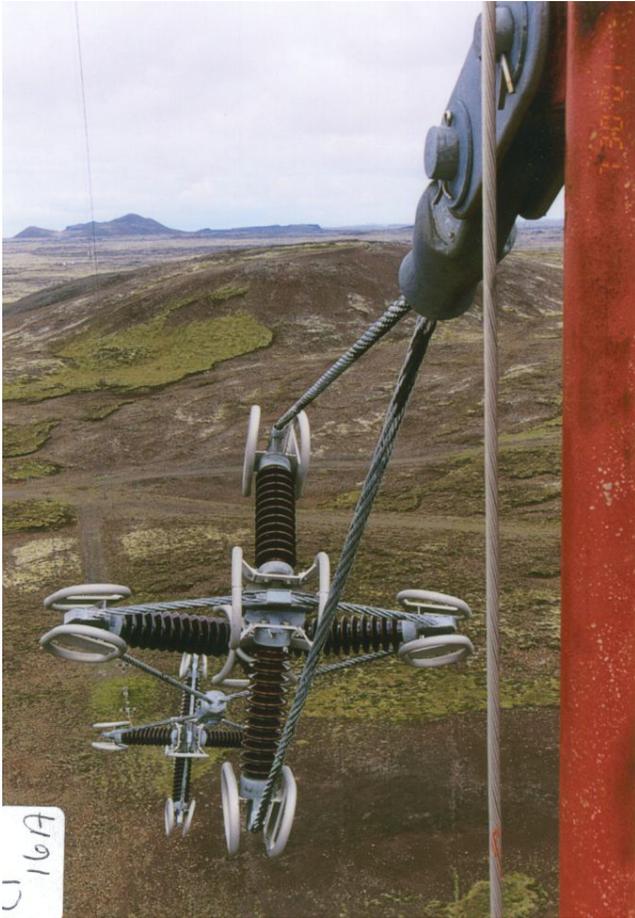
Photo No. 20 shows a typical first level guy insulator in good condition. Photo No. 21 shows typical corroded riser wire support band and rust along tower leg near the 220' level. All the support bands should be replaced and the tower cleaned and painted within one year.

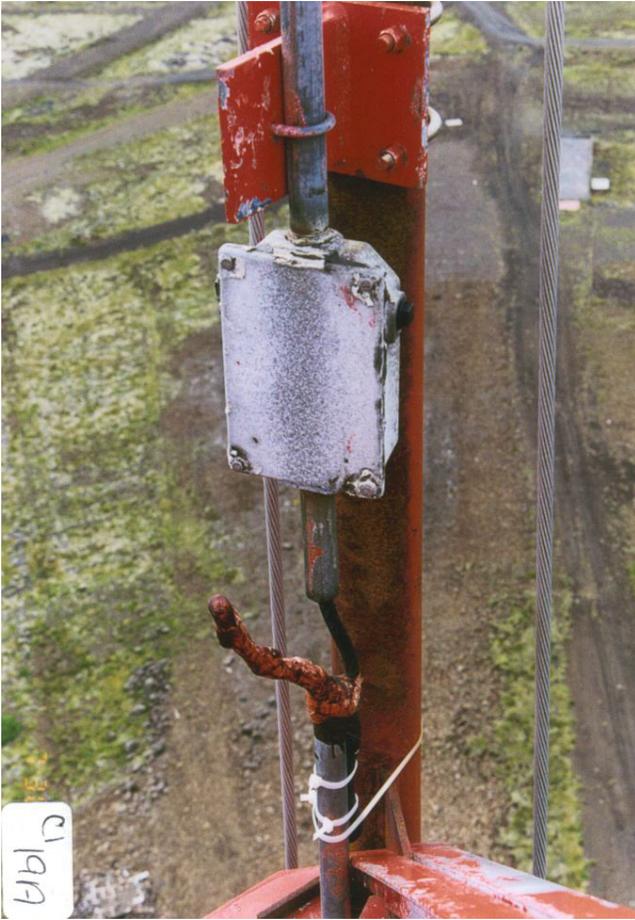
Photo No. 22

Obstruction lighting conduit along Column B was not continuous near the 240' level (Photo No. 22). All lighting system wiring and conduit should be replaced within one year. Local forces had installed stainless steel boxes on Column A, shown here at the 240' level. At the time of the inspection, these boxes were not in use (Photo No. 23).

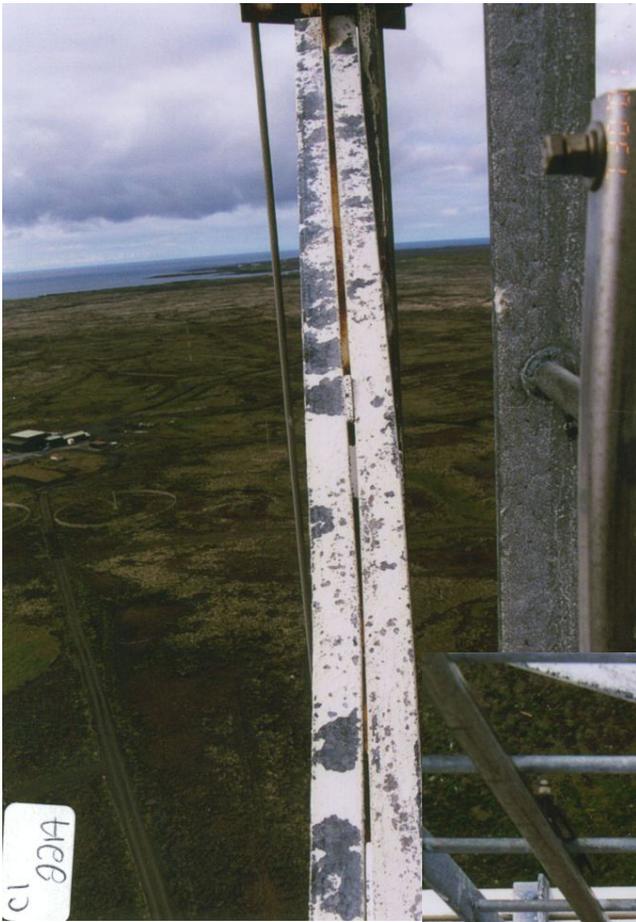
Photo No. 24

STRUCTURAL MEMBERS — Two diagonals were deflected on Face A at the 270' level (Photo No. 24) and at the 260' level (Photo No. 25). These damaged members were previously noted in the FY91, FY93, and FY95 Inspection Reports. Both members should be replaced within one year.

Photos No. 24 and 25 show deflected diagonals on Face A at the 270' and 260' levels, respectively. Both members should be replaced within one year.

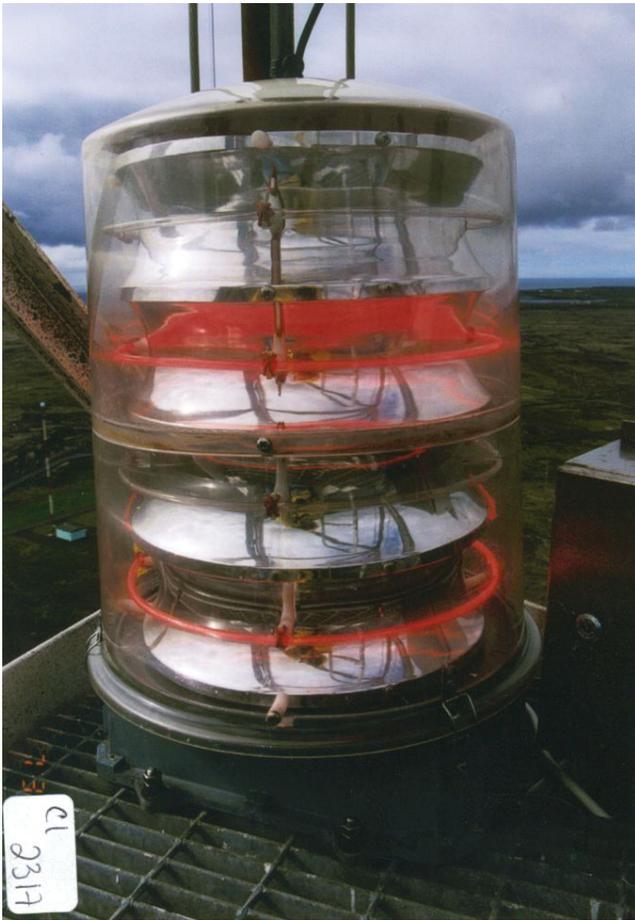
Photo No. 26

Two of four beacon cathode tubes were not functioning at the 300' level (Photo No. 26). The beacon should be lowered and the light dome replaced with the local forces' spares immediately. Photo No. 27 shows rust along the tower leg at the 300' level. Because of the deteriorated paint coverage, the tower is no longer conspicuously marked for aircraft during daylight hours. The tower should be mechanically cleaned and painted within one year.

- 1) Lower mid-level and top level beacons and replace with local forces' spares (Photos No. 26 and 34). Beacon is an Alstom ZA766 with a total weight of 93 lbs. Install a new bulb at the third light level (Photo No. 32) and install new wiring to this light level.

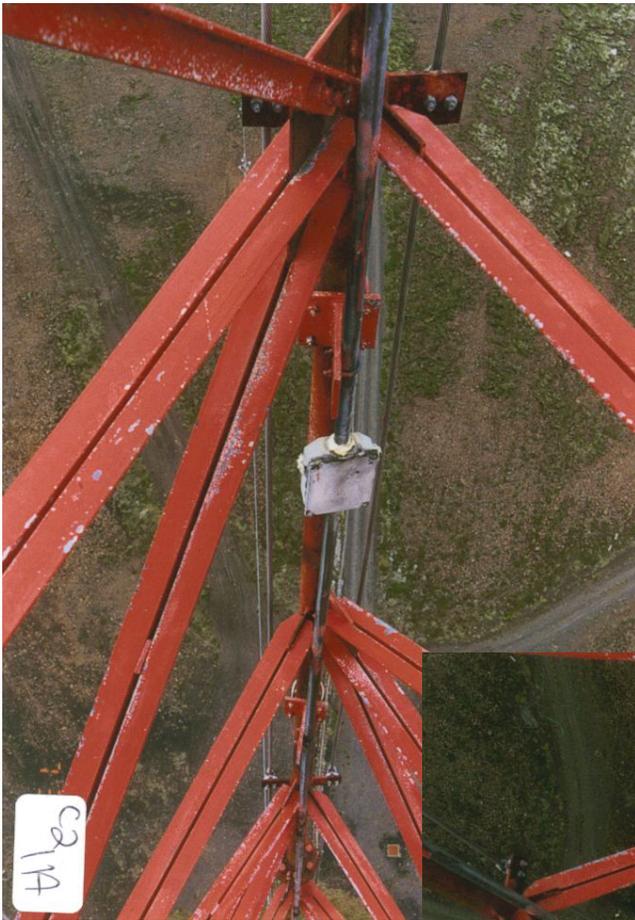
Photo No. 28

Junction box near the 380' level was missing a cover screw (Photo No. 28). Photo No. 29 is a view down the center of the tower from the 360' level showing rust along the tower legs with 20% obstruction paint missing from the lacing members. The tower should be mechanically cleaned and painted within one year conforming to FAA color banding guidelines.

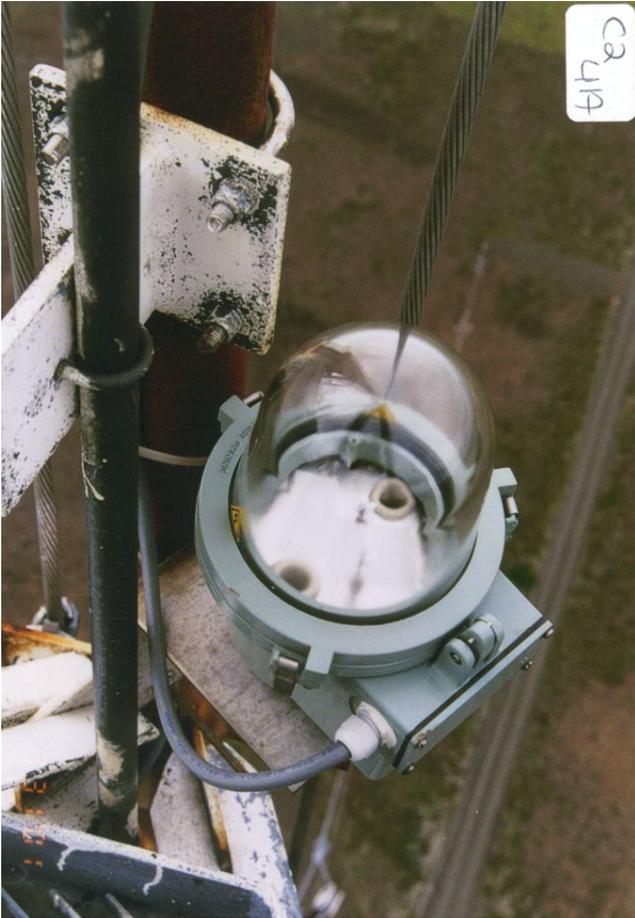
Photo No. 32

A steady burning light at the third light level was missing a bulb (Photo No. 32). A new bulb should be installed immediately. Photo No. 33 is a view looking down from the top of the tower showing rust along a tower leg and paint coverage loss on the lacing members. The tower should be mechanically cleaned and painted within one year.

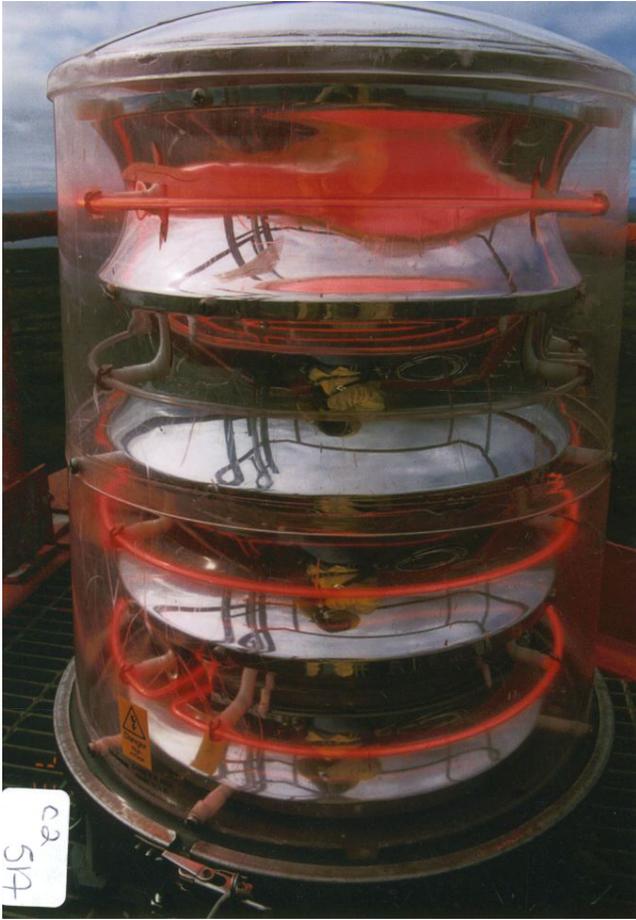
Photo No. 34

One of four beacon cathode tubes was not functioning at the top beacon (Photo No. 34), and the inner coating at the top of the light dome had deteriorated (Photo No. 35). The beacon should be lowered and the light dome replaced with the local forces' spares immediately.

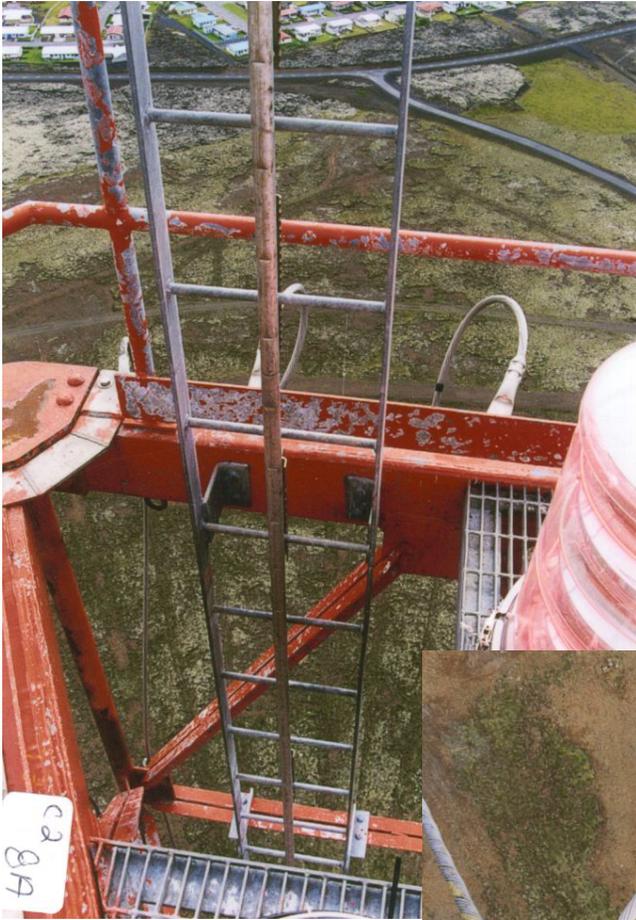
Photo No. 36

Top platform was not equipped with ladderway opening protection (Photo No. 36). Installation of ladderway opening protection would bring the platform into compliance. Photo No. 37 shows top radial connections in good condition at the top of the tower.

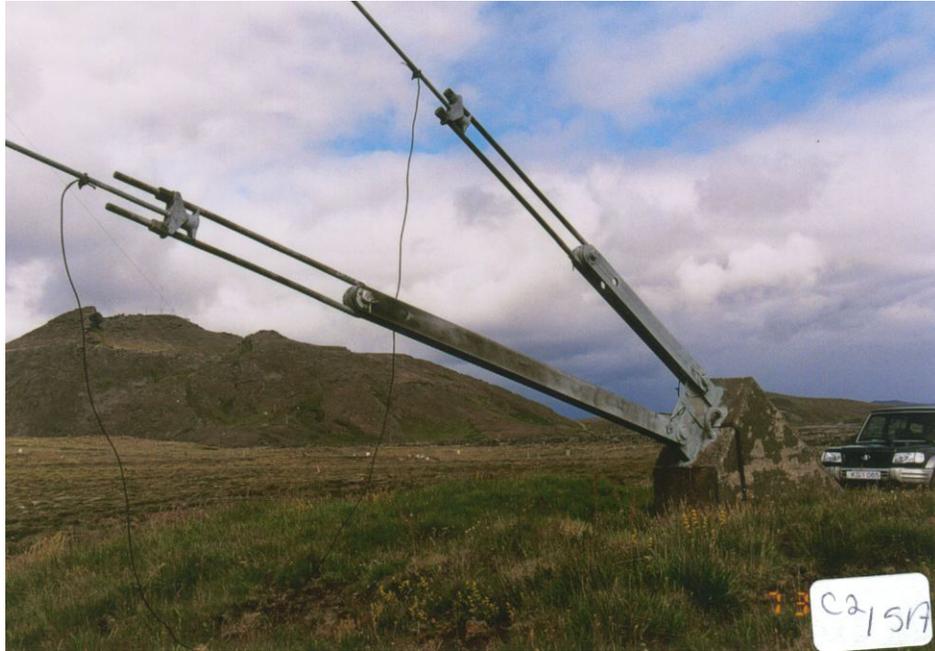
Photo No. 38

GUY SUBSYSTEM — Hairpins were fully extended at ten anchors (Photos No. 38 and 39). Anchors affected were first level guy anchor C, second level guy anchor C, second level guy anchor A, and radial anchors 2, 3, 4, 5, 6, 10 and 12. The next time the guy wires are tensioned and the tower plumbed, attempts should be made to center the sockets on the hairpins to facilitate future tension adjustments. If it is not possible to center the sockets while maintaining proper tensions and verticality, it may be necessary to install additional link plates at the anchors to extend the hairpins toward the tower and accommodate additional adjustments (No cost estimate is included for these items).

Photos No. 38 and 39 show fully extended hairpins at a guy anchor and radial anchor, respectively. This condition was typical at first level guy anchor C, second level guy anchor C, second level guy anchor A, radial anchors 2, 3, 4, 5, 6, 10 and 12. The next time the guy wires are tensioned and the tower plumbed, attempts should be made to center the sockets on the hairpins to facilitate future tension adjustments. If it is not possible to center the sockets while maintaining proper tensions and verticality, it may be necessary to install additional link plates at the anchors to extend the hairpins toward the tower and accommodate additional adjustments.

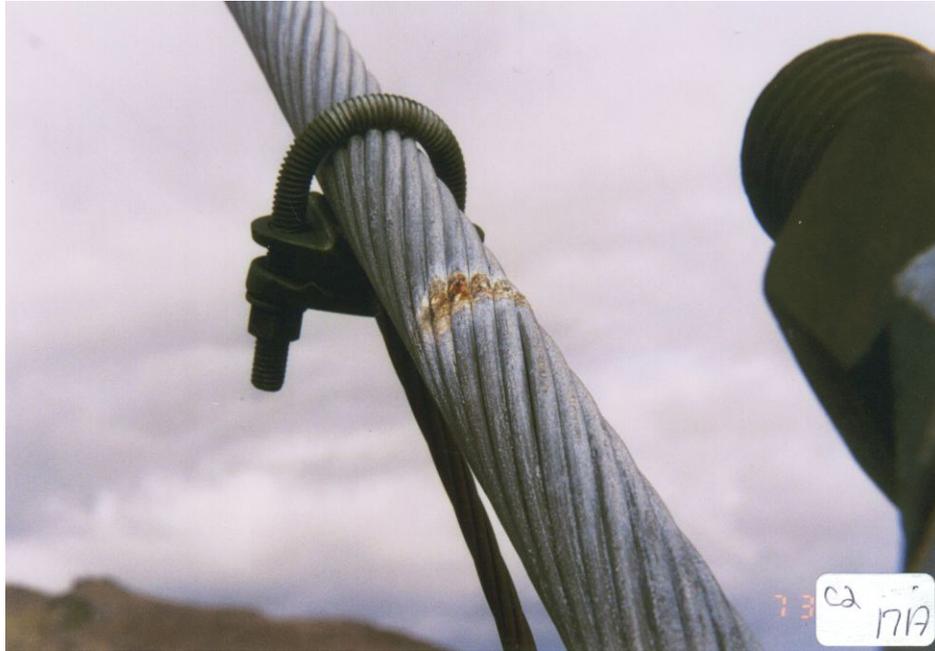
Photo No. 40

Inspectors noted corrosion on guy wires where ground clamps were once connected (Photos No. 40 and 41). Within one year the corrosion should be mechanically cleaned and coated with a cold-galvanizing compound and conductive grease should be applied beneath the clamps to prevent further corrosion.

Photos No. 40 and 41 show corrosion on guy wires where grounding clamps were once connected. Within one year the corrosion should be mechanically cleaned and coated with a cold-galvanizing compound and conductive grease should be applied beneath the clamps to prevent further corrosion.

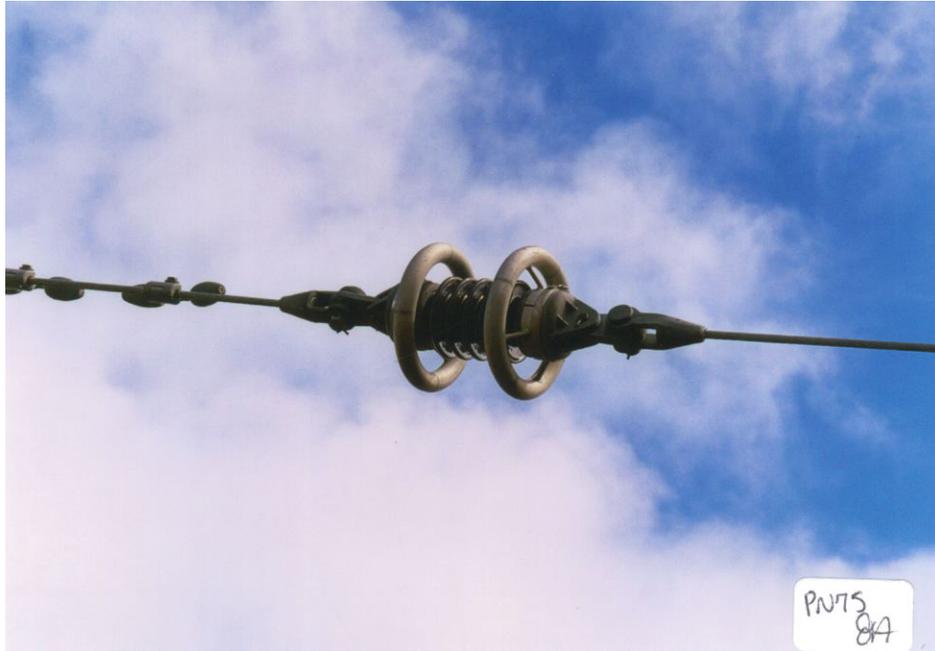
Photo No. 42 shows a typical good insulator near Radial 4 anchor. Photo No. 43 is a view of a typical good corona ring on Radial 11.

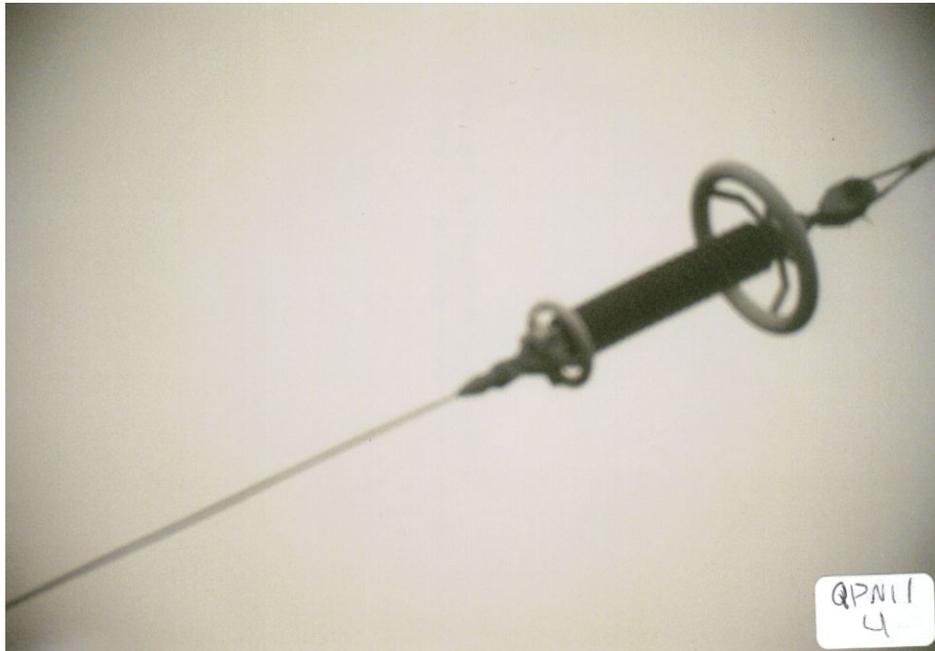
Photo No. 44

Inspectors examined the first insulator from the tower on all radial spans through a Questar telescope and noted minor rusty cotter pins and minor corrosion on a socket (Photos No. 44 and 45). No action is required.

Inspectors noted rusty cotter pins on the first insulators from the tower on the radial wires (Photo No. 44), however no action is necessary. Inspectors noted minor corrosion on a socket, however no action is necessary (Photo No. 45).

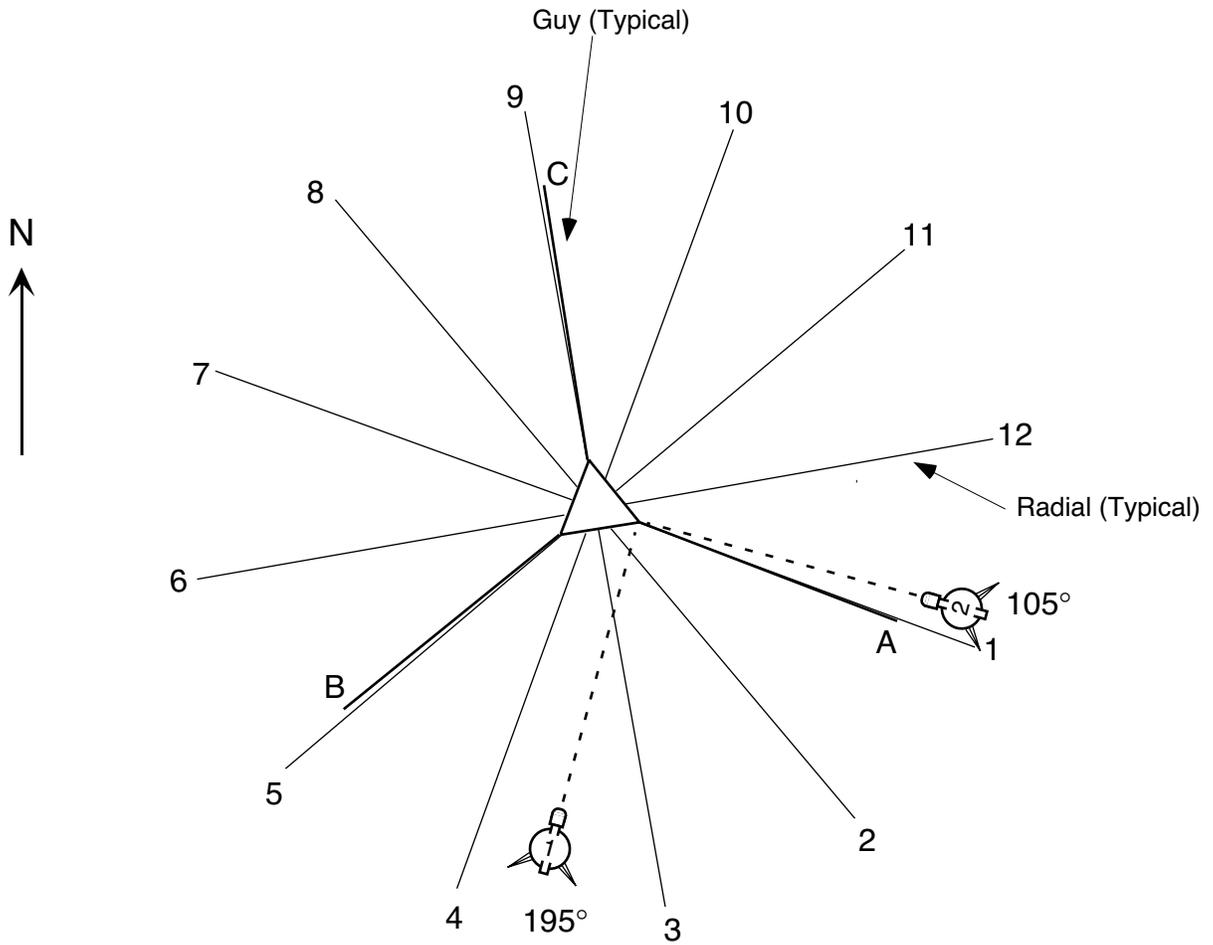
VERTICALITY TABULATION
 600' Guyed Tower No. 2637
 Grindavik Transmitter Site, Iceland

VERTICALITY — The tower's verticality was satisfactory with the largest deviation being 3.75" at the top.

Elevation	Deviation from Vertical		Elevation	Deviation from Vertical		Elevation	Deviation from Vertical
Mid Span	0	1 L	2nd Guy	2.5 L	1.75 L			
1st Guy	1.5 L	1 L	Mid Span	2.75 L	2.5 L			
Mid Span	2.5 L	1.5 L	Top	3.75 L	3 L
