Contract No. N62470-99-D-3251
High Antenna Tower System Inspection

Metallurgical Study
Corona Rings in the 1000' Guyed Tower
Grindavik, Iceland
Inspection Date: July 8-13, 2002

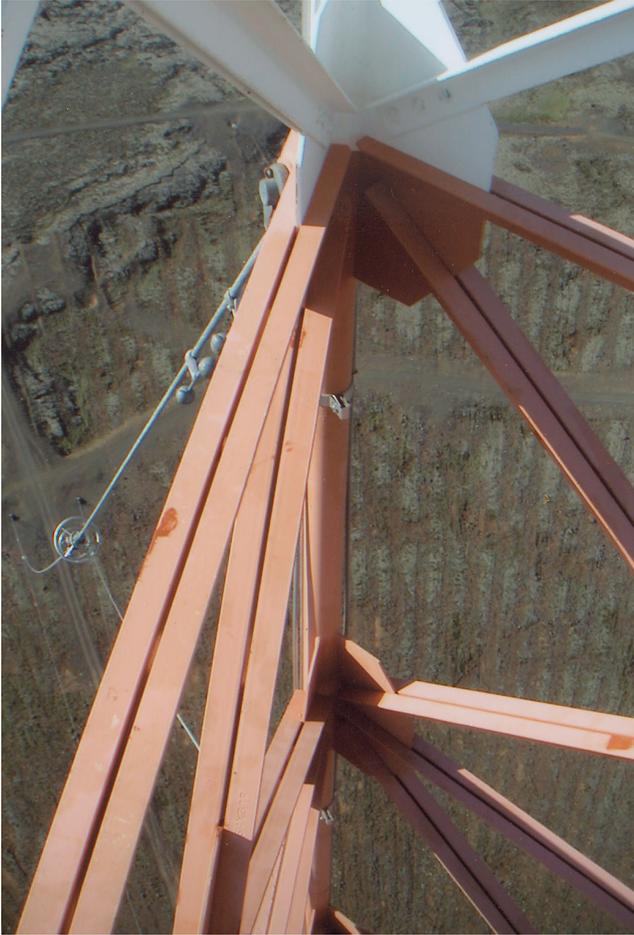
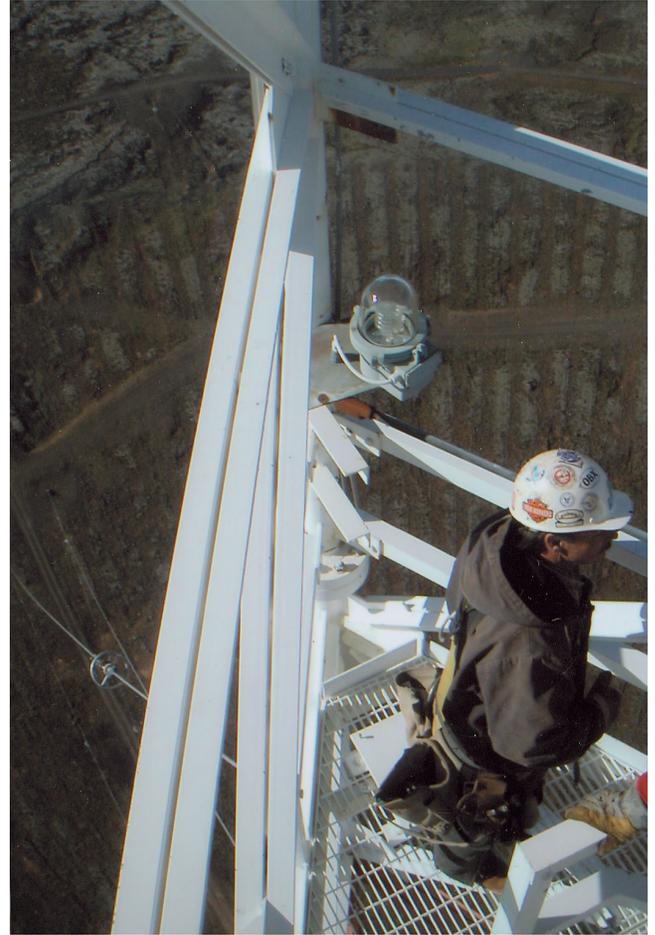
Photos No. 1 and 2 are representative of the good condition of the tower members at the upper guy level connection and one level above and below this point.

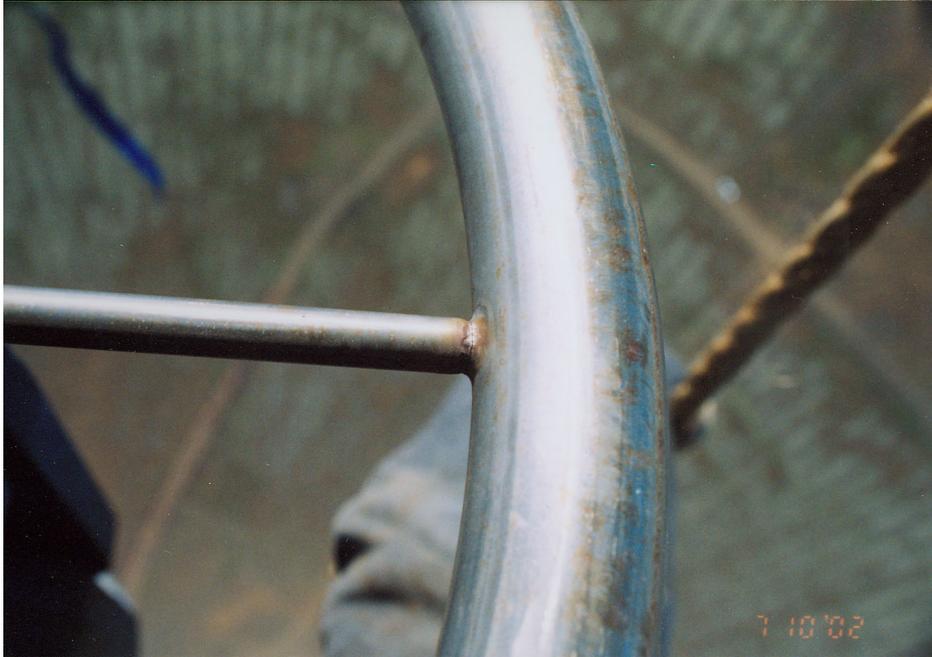
A close-up visual inspection of the top insulator and corona rings of guy UG-3U was performed by D. Kaiser. One broken weld was noted in the lower corona ring of the top insulator (Photo No. 3). The other welds looked similar in appearance to those of the middle and lower insulators and we believe that similar results would be obtained if they were radiographically tested. It should be noted that during a recent tower inspection of this tower, all corona rings were thoroughly inspected through a Questar telescope. The inspectors were aware of the weld concerns and paid particular attention to the corona ring spoke connections. Unless there is significant separation between the spoke and the ring, identification of weld breaks such as the one noted in Photo No. 3 are impossible through the Questar telescope.

Conclusions — Inadequate weld penetration and the relatively small size of the corona ring spokes, combined with the vibration associated with the typically windy conditions at Grindavik resulted in the failure of these corona rings. We believe that there are additional broken welds that have not been identified and that radiographic testing of currently installed corona rings would produce similar results with many inadequate welds. The only long-term solution is to replace all corona rings throughout the tower. Consideration should be given to increasing the diameter of the corona ring spokes to provide additional weld area. In this event the sheds were the only damaged part of the insulator but that may not be the case next time. We recommend that this work be accomplished as soon a practical with a completion date of the summer of 2004.

Photo No. 3 shows a broken weld in the lower corona ring of the top insulator of guy UG-3U.

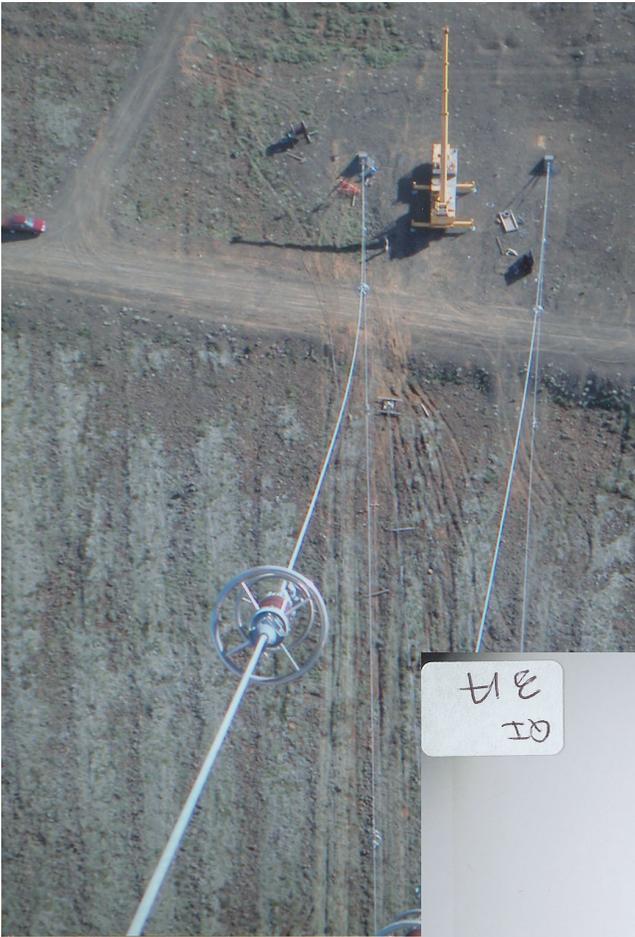
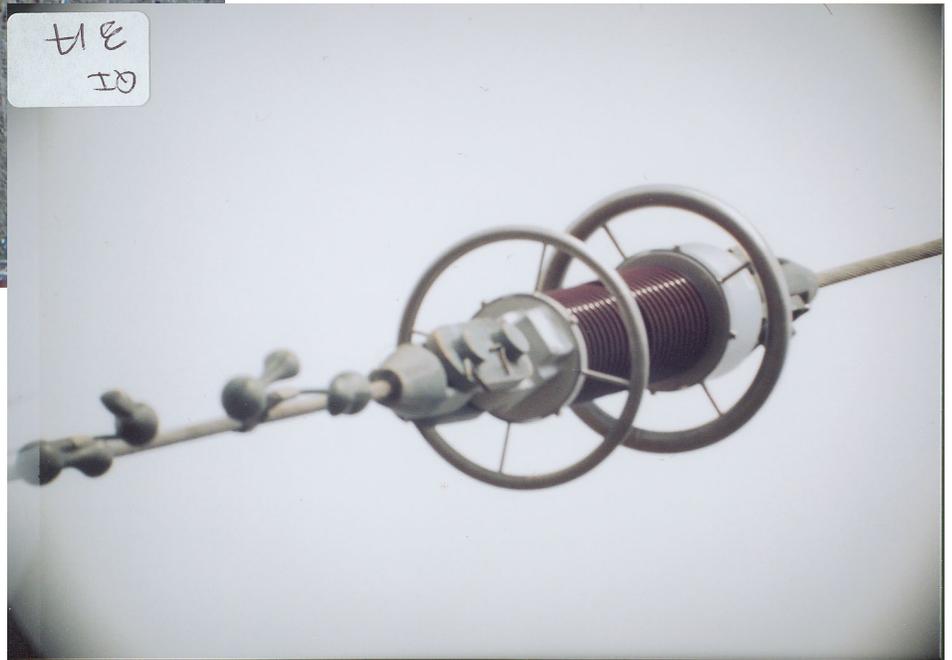
Photo No. 4 shows the crane and hoist in position and the upper third level guy UG-3U after installation of the new insulator and corona rings. Photo No. 5 shows the new insulator and corona rings as viewed through the Questar telescope.

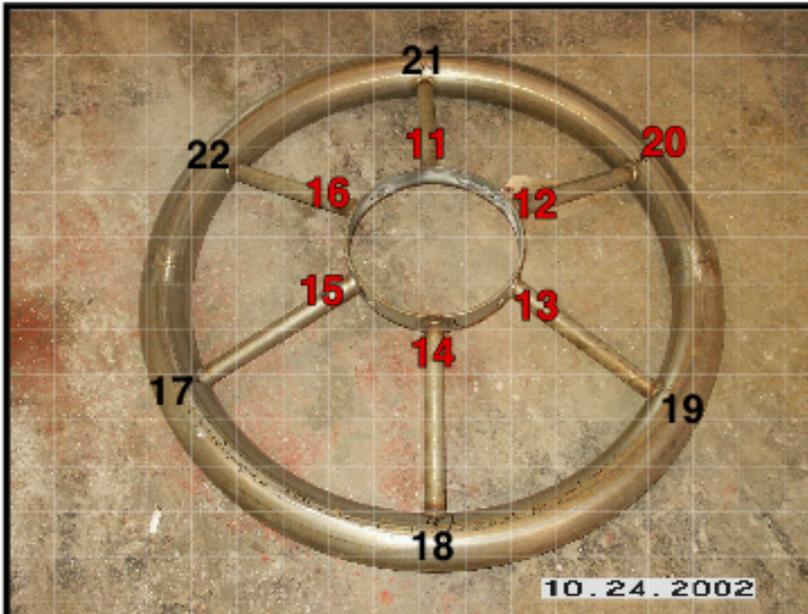
Photo No. 6

Failures: 7 (in red)

Type: Inadequate Penetration

Locations: #11-#16, #20

Third Guy Level - Middle Insulator - Top Ring

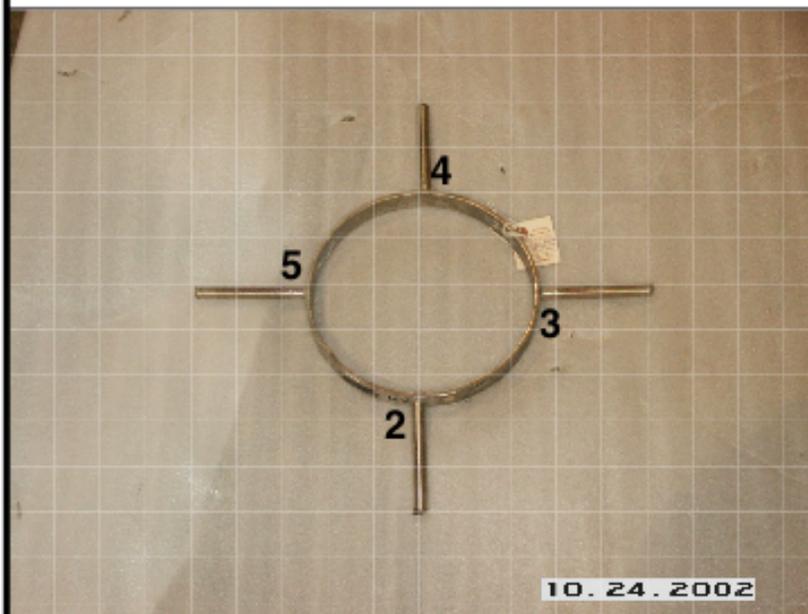
Photo No. 7

Failures: 0

Third Guy Level - Middle Insulator - Lower Ring

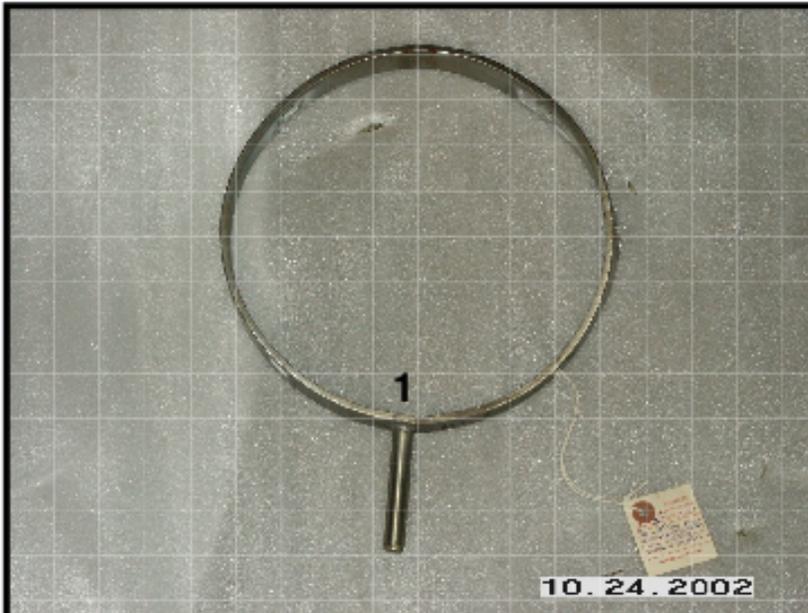
Photo No. 8

Failures: 0

Third Guy Level - Lower Insulator - Top Ring

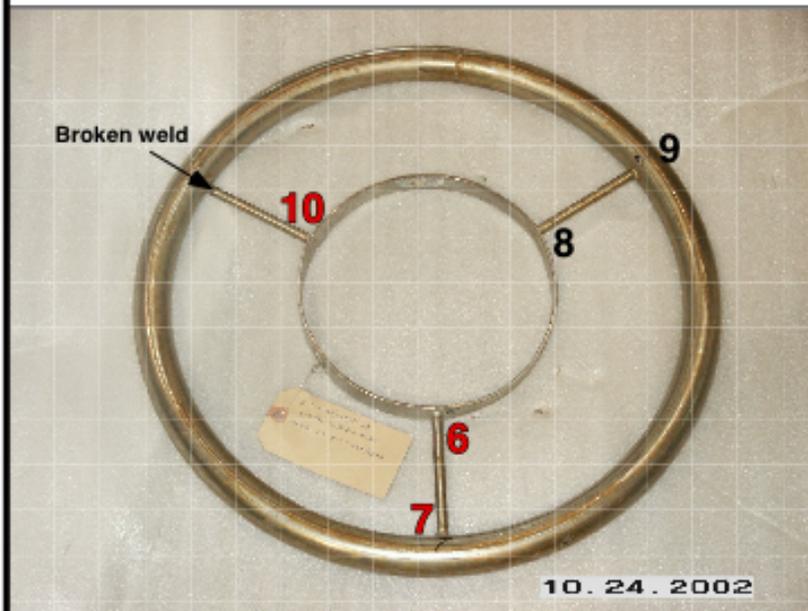
Photo No. 9

Failures: 3 (in red) not including broken weld

Type: Inadequate Penetration

Locations: #6, #7, #10

Third Guy Level - Lower Insulator - Lower Ring
