Naval Facilities Engineering Command
200 Stovall Street
Alexandria, Virginia 22332-2300

Lessons Learned from Design & Engineering of Naval Facilities

NAVFAC P-1010
October 1985

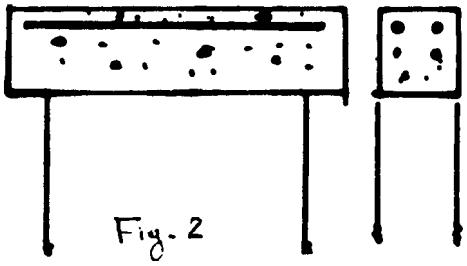
Fig. 2

Collection of Facts: This project involved a complex of multi-story apartment buildings with brick bearing walls, steel columns, beam and joists. A structural evaluation of the precast reinforced concrete lintels was made from the design drawings and they were found adequate to carry the design loads. During the investigation, it became obvious that the location of the reinforcement was unknown after the fabrication of the lintels. Therefore, a great number of lintels were placed over the openings with the reinforcement on the compression side of the lintel (The top of the lintel. See Fig.2). This was verified by removing a number of lintels and exposing their reinforcement. Removing the cracked lintels and replacing them with new lintels was a costly process since it was necessary to remove and replace part of the already constructed brick wall over the lintels.

Solution: Use top and bottom reinforcement in precast concrete lintels to eliminate the possibility of misplacement. See Figure 3.

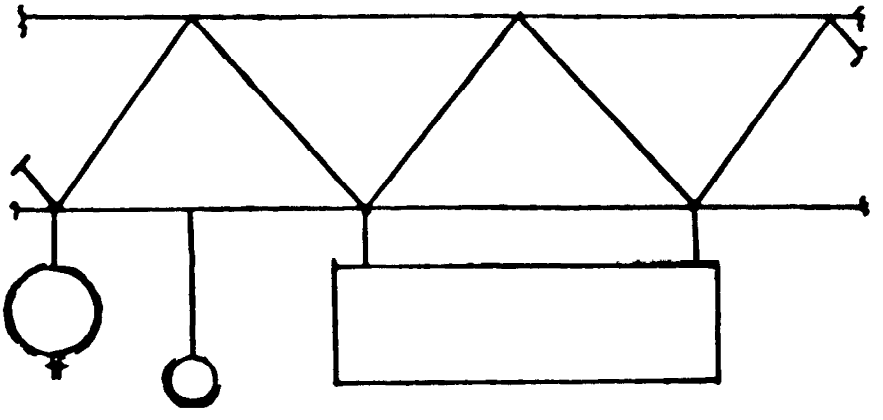
Fig. 4

Symptoms: A visual inspection showed excessive deflection of the roof trusses with indications of cracks and torsion at the bottom elements of the trusses. Measurements taken indicated deflections in excess of 2 inches.

Collection of Facts: A storage building located at NAS Patuxent River was designed with steel columns and roof trusses. A structural analysis was performed based on the original loading conditions. Stresses and deflections were found to be within allowable limits. Results of a material survey indicated that the trusses were maintained properly without evidence of corrosion or any other type of material deterioration. During the site survey it was found that various sizes of piping from 1 inch to 6 inches in diameter and heavy air conditioning units were supported by bottom elements of the truss (see Fig. 4). This additional loading was imposed on the trusses in various times after the original construction. A new structural analysis which included the additional loading substantiated the cause of distress.

Solution: To correct this situation, it was recommended that the additional loading be immediately removed from the bottom of the trusses. Secondly, a repair procedure was initiated to eliminate the imposed deflection and repair the damaged members. A very useful lesson to be learned from this case is to compare the original loading conditions with the existing conditions during the structural investigation. In many projects, alterations are made during the initial stages of construction which are not followed by preparation of as-built drawings. In these cases, a structural analysis based on original drawings and loading conditions will result in erroneous findings.

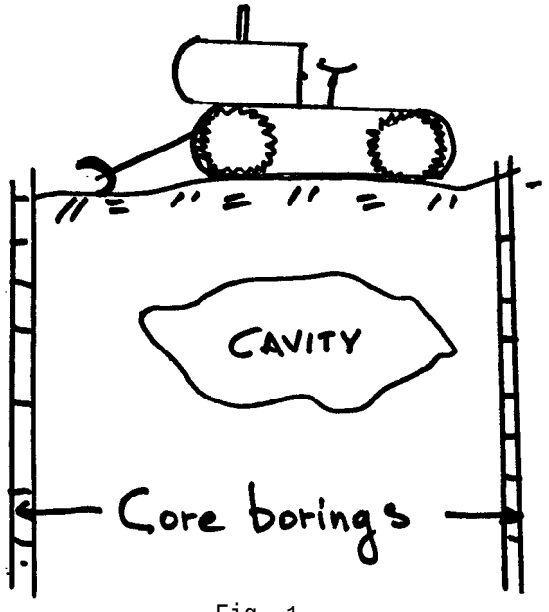
Fig. 1

Collection of Facts: A geotechnical company was engaged to perform soils investigation at the site of a proposed very sensitive building. The general trend is to minimize the number of soil borings and spend as little money as possible in geotechnical investigations. In this case, the depth of borings was adequate but the number unreasonably small for the size and the sensitivity of the building. The subsurface conditions were described in the soils report as favorable for pile foundation system. The contractor proceeded to perform a shallow excavation by using earth moving equipment, The operation started smoothly, (see Fig. l), until a Caterpillar D-6 bulldozer started sinking due to settlement of the soil (see Fig. 2). A detailed subsoil investigation concluded that, prior to the failure, a number of cavities of various size existed at the proposed building site which were not uncovered during the original soil investigation. An extensive soil boring program was undertaken and most of the cavities were uncovered.

Solution: The cost of soil borings is minimal in comparison with the total construction cost. Particularly in special structures, where small deflections and settlements are critical, extensive geotechnical evaluation imperative. The number of soil borings must be reasonable enough to insure comprehensive knowledge of the subsurface conditions.

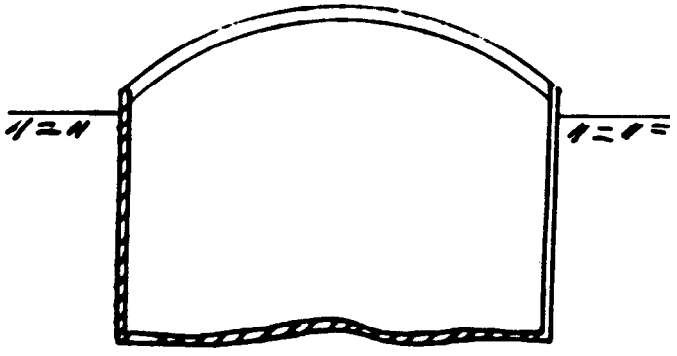
Fig. 1

Symptoms: Upon completion of the project and before filling with fuel, the steel bottom plates buckled and warped (See Fig. 1). Cracking also occurred in several areas of the steel plates.

Collection of Facts: Upon inspection of the site, it was apparent that an upwards force had caused the failure. A geotechnical evaluation revealed a water table close to the ground elevation. However, the tank was designed without consideration of the uplift force due to hydrostatic head. Therefore, no provisions for anchorage of the bottom were made.

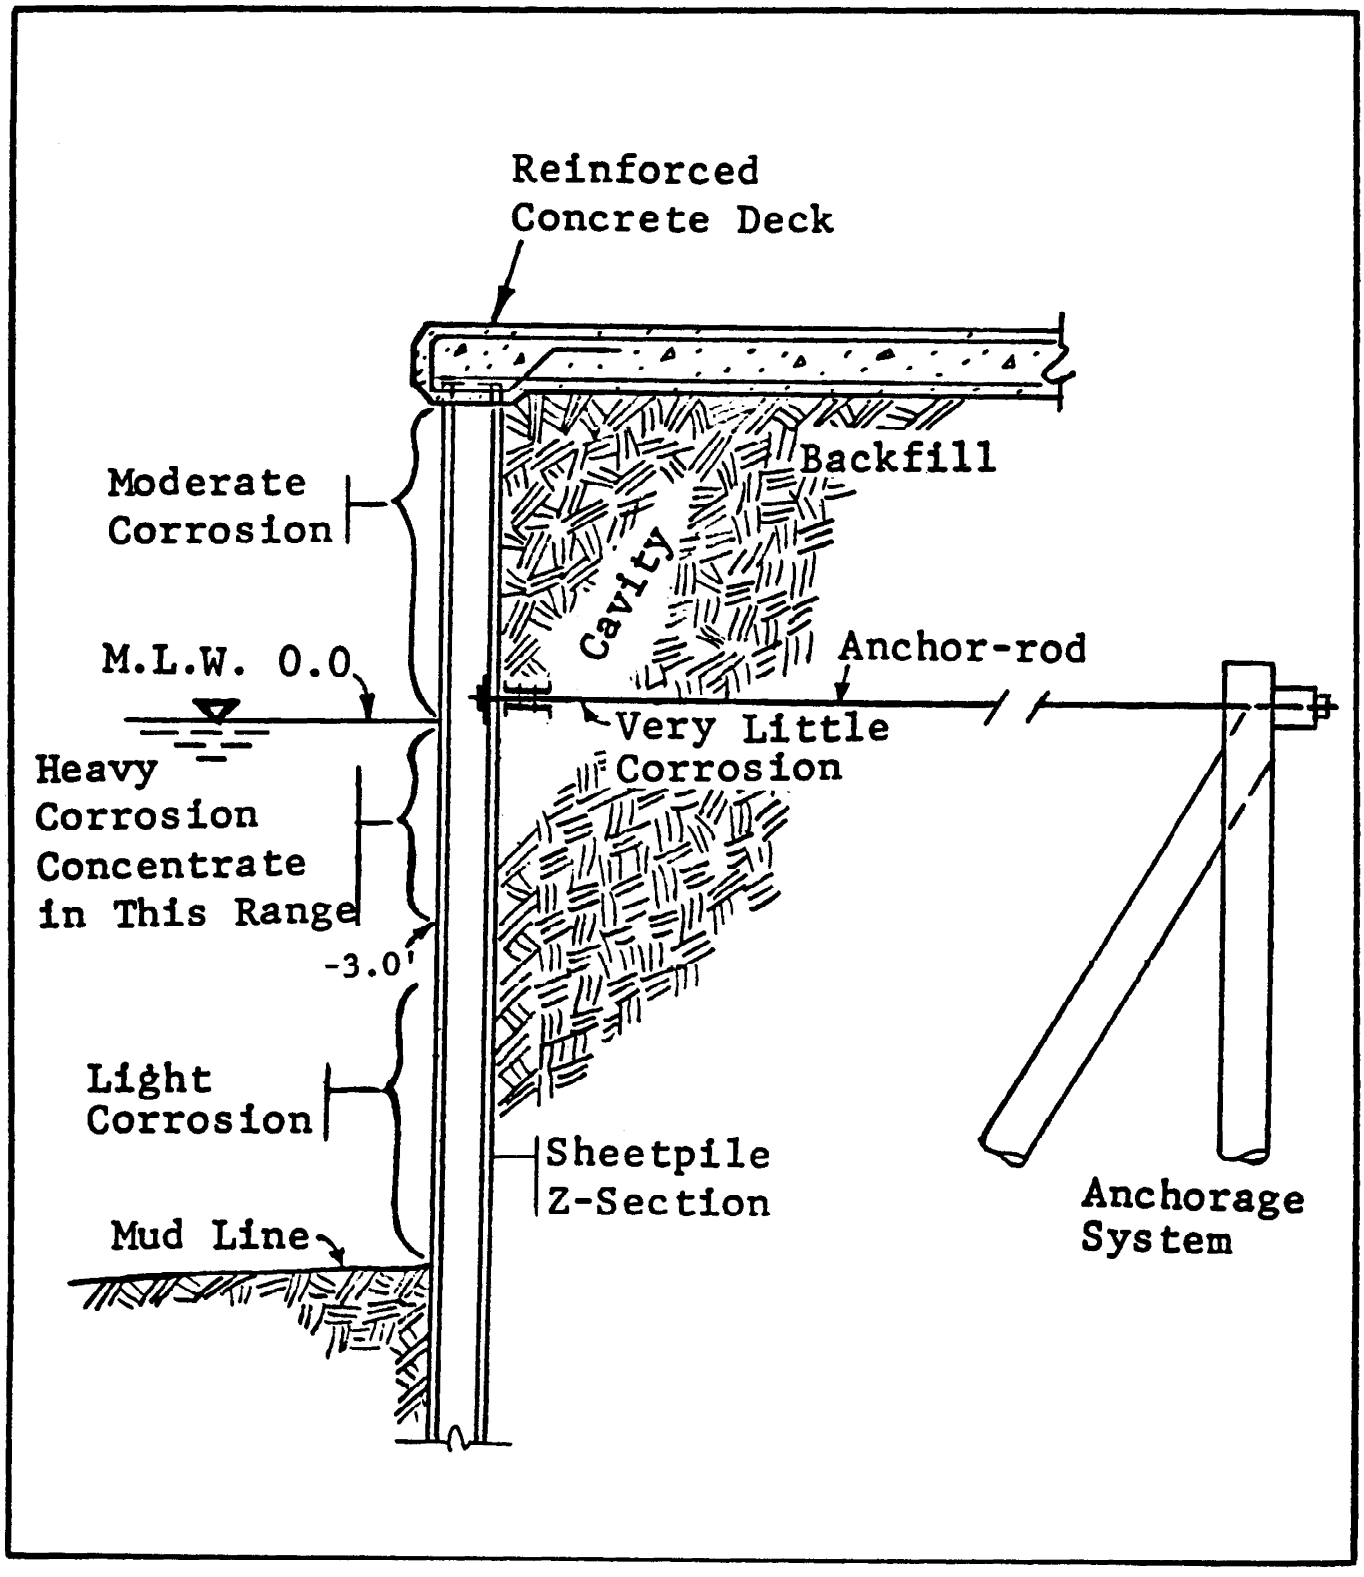
Fig. 2. Anchored Bulkhead After 25 Years in Service (Ref. 3)

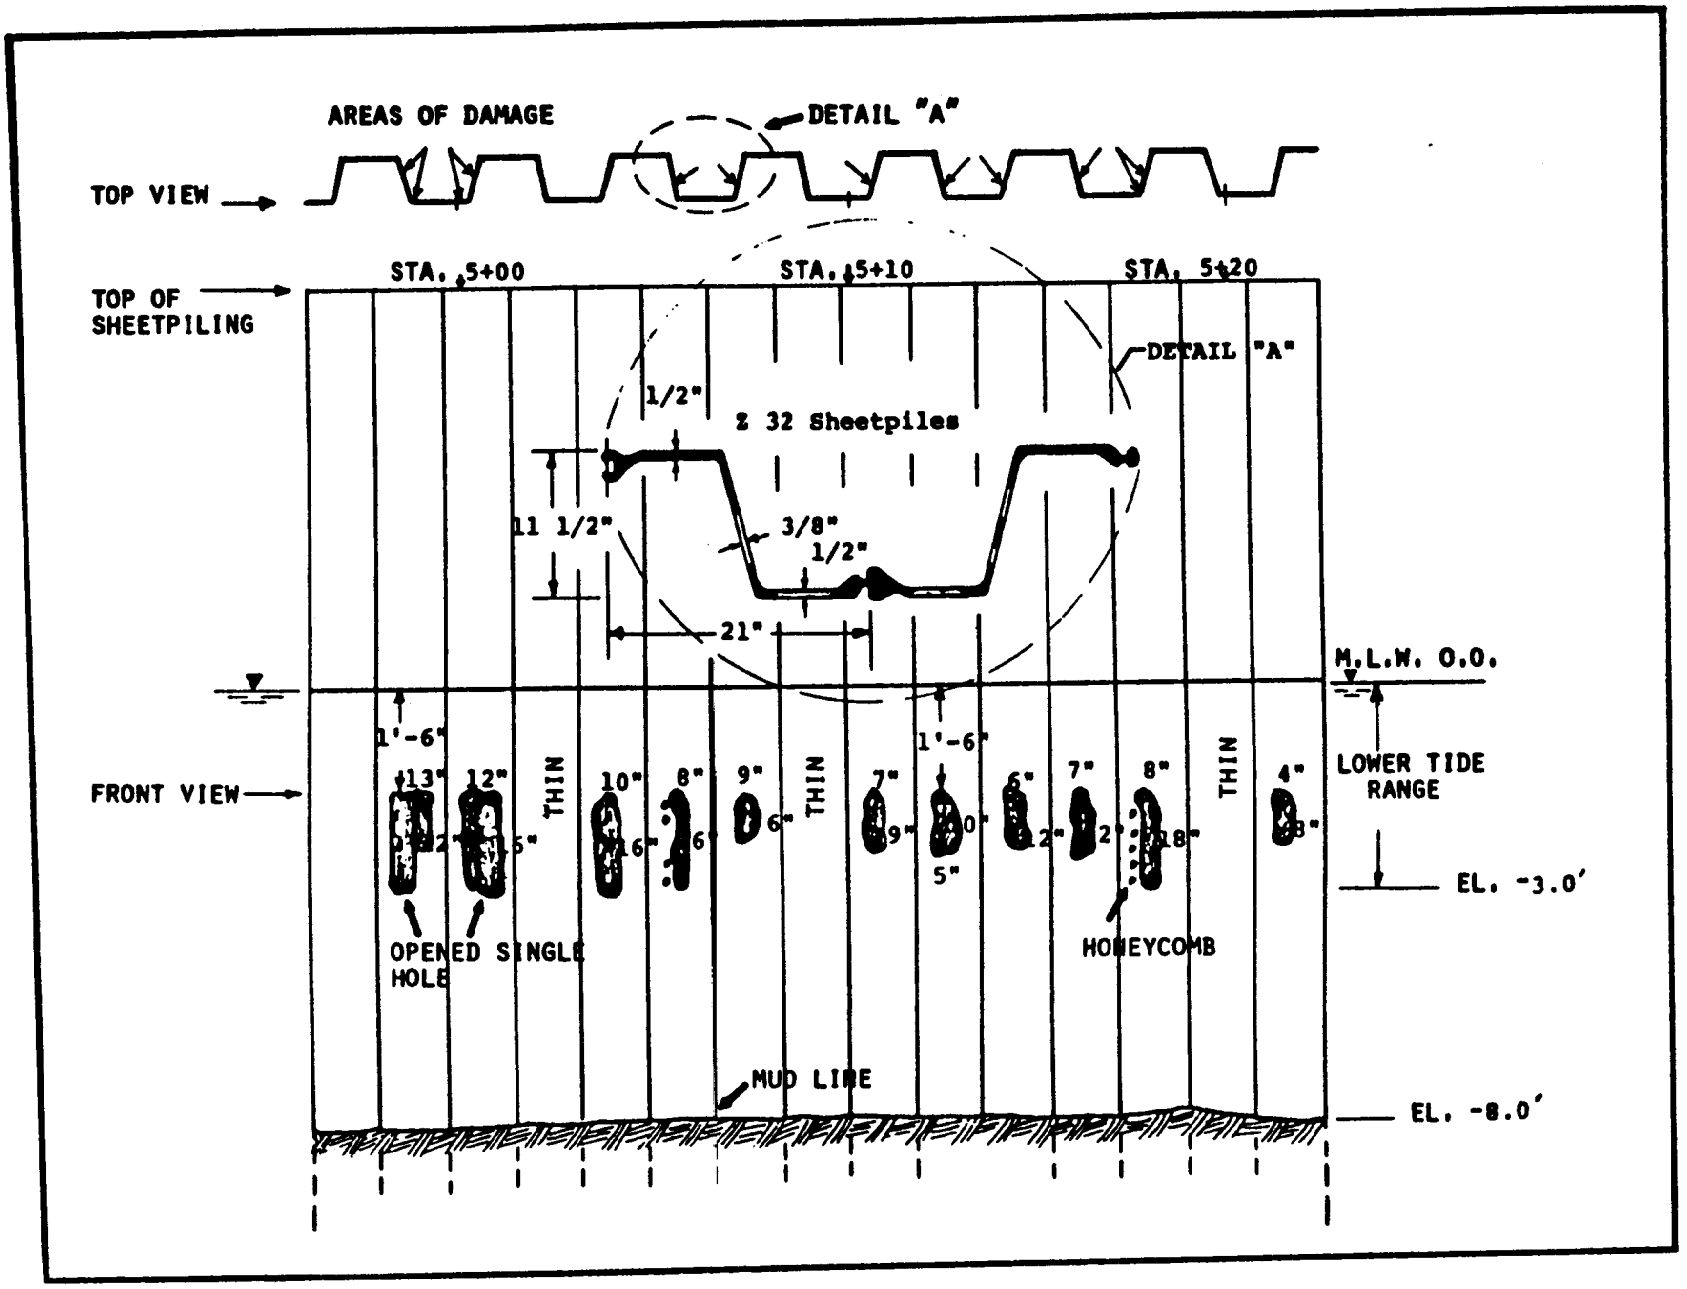
Fig. 3. Sheetpile Corrosion After 28 Years in Service (Ref. 3)

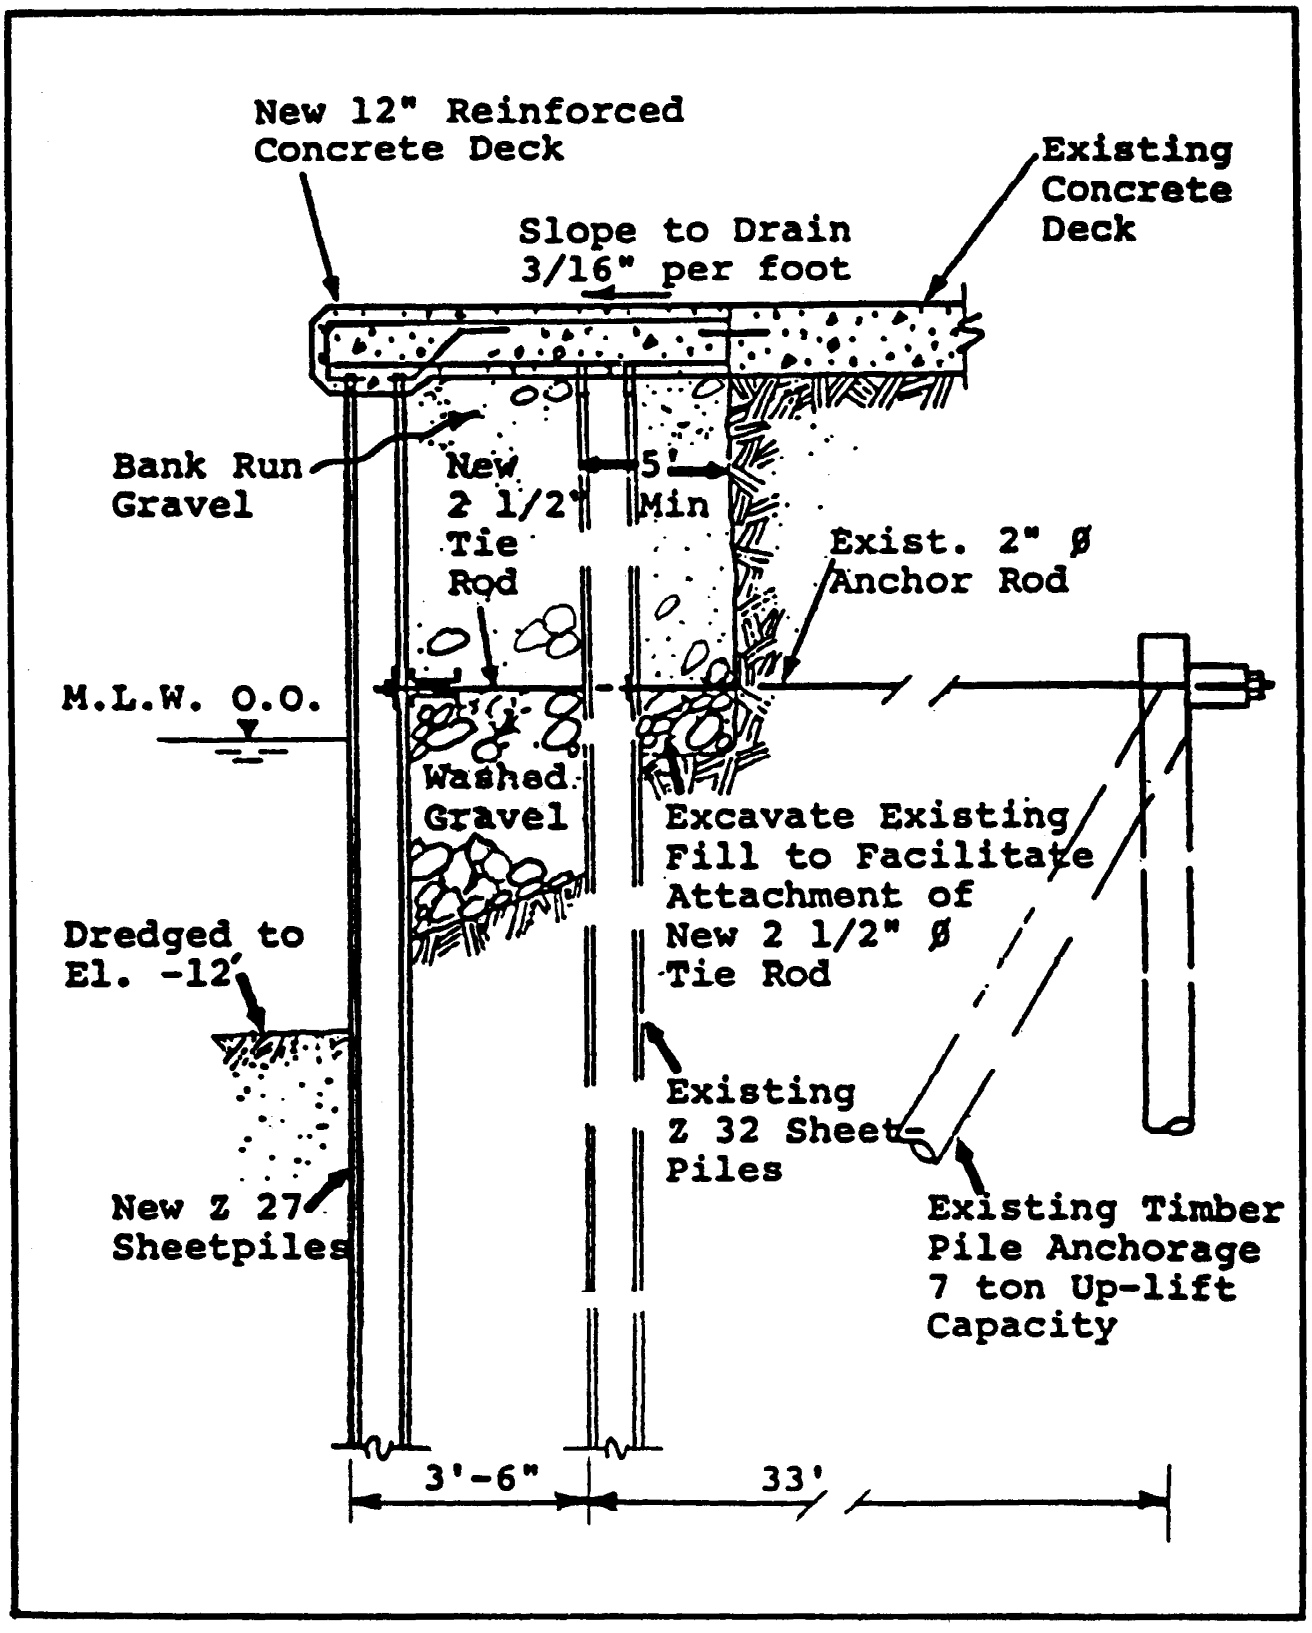
Fig. 4. Bulkhead Replacement, U. S. Naval Station Annapolis, Maryland (Ref. 3)

If an anchored bulkhead has corroded after many years of service, but is structurally stable and field inspection revealed that the anchorage system is in good condition, then a cost effective replacement method may be adopted using the above method. The new sheetpile need not be installed deeper than the existing sheetpile unless dredging in front of the new wall is needed.

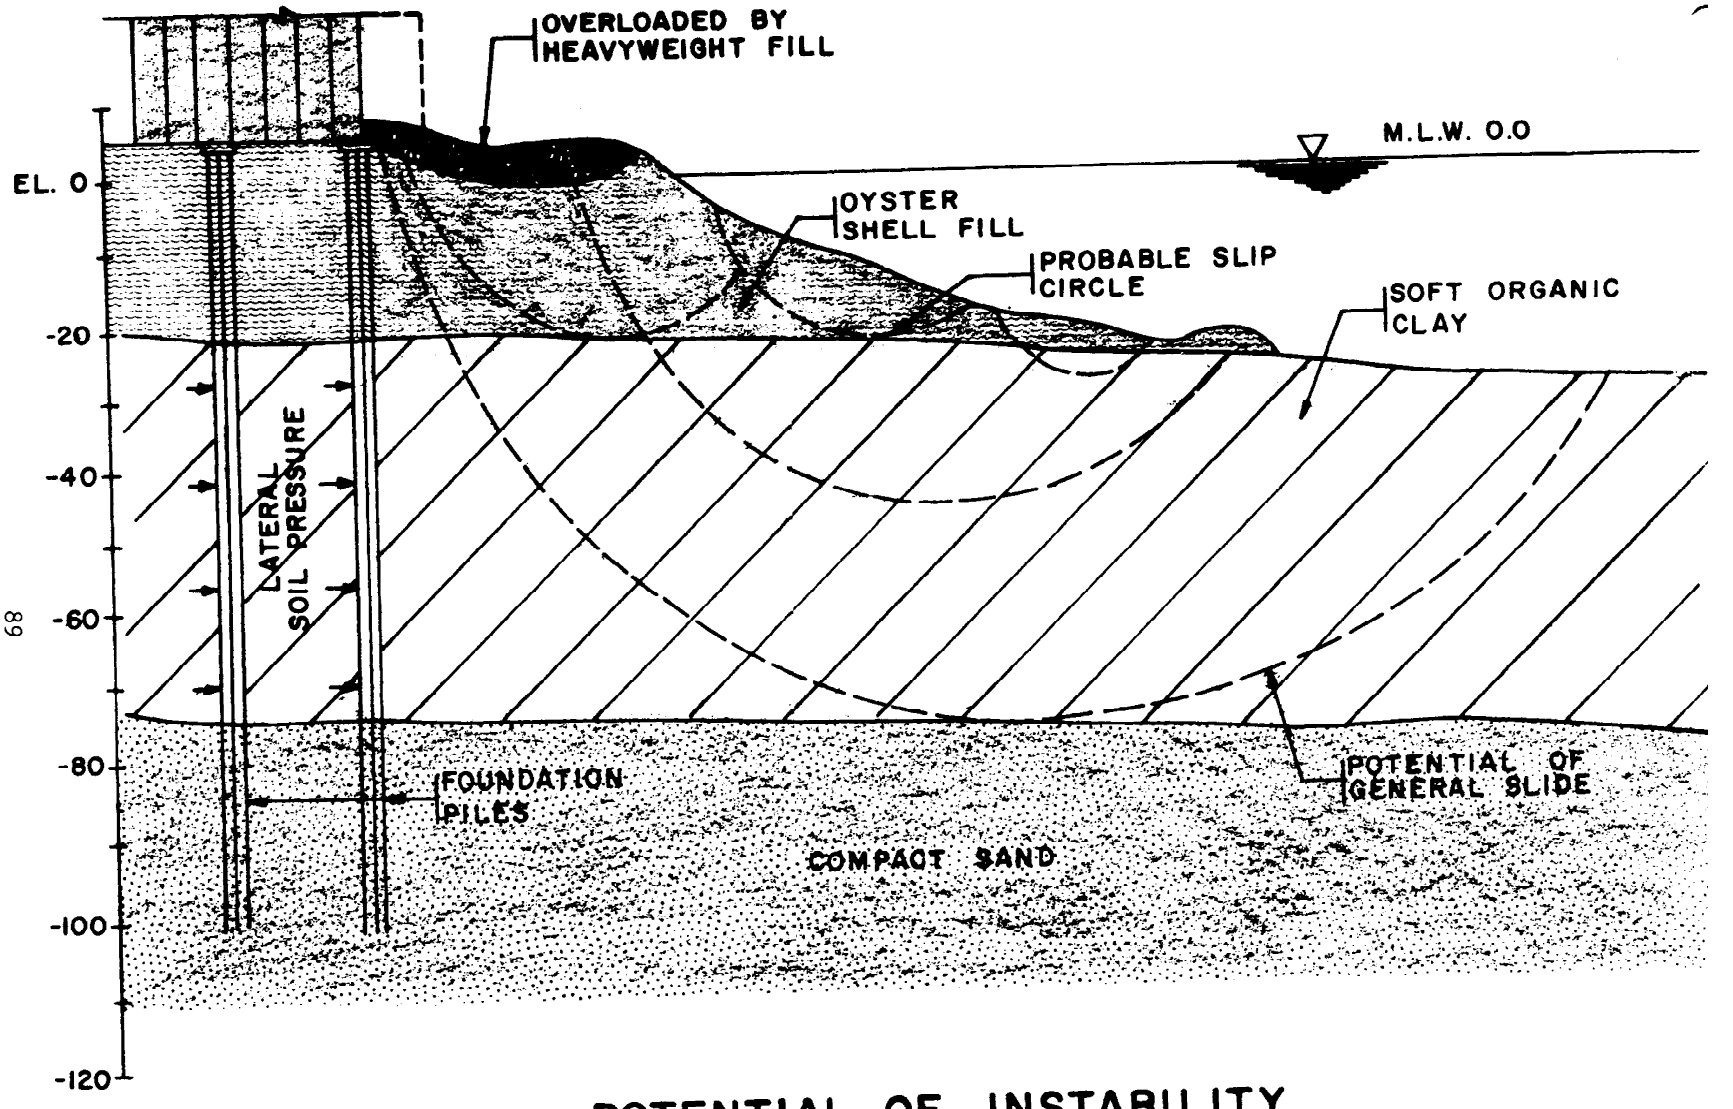
Fig. 1

POTENTIAL OF INSTABILITY WITH EXISTING SITE CONDITIONS

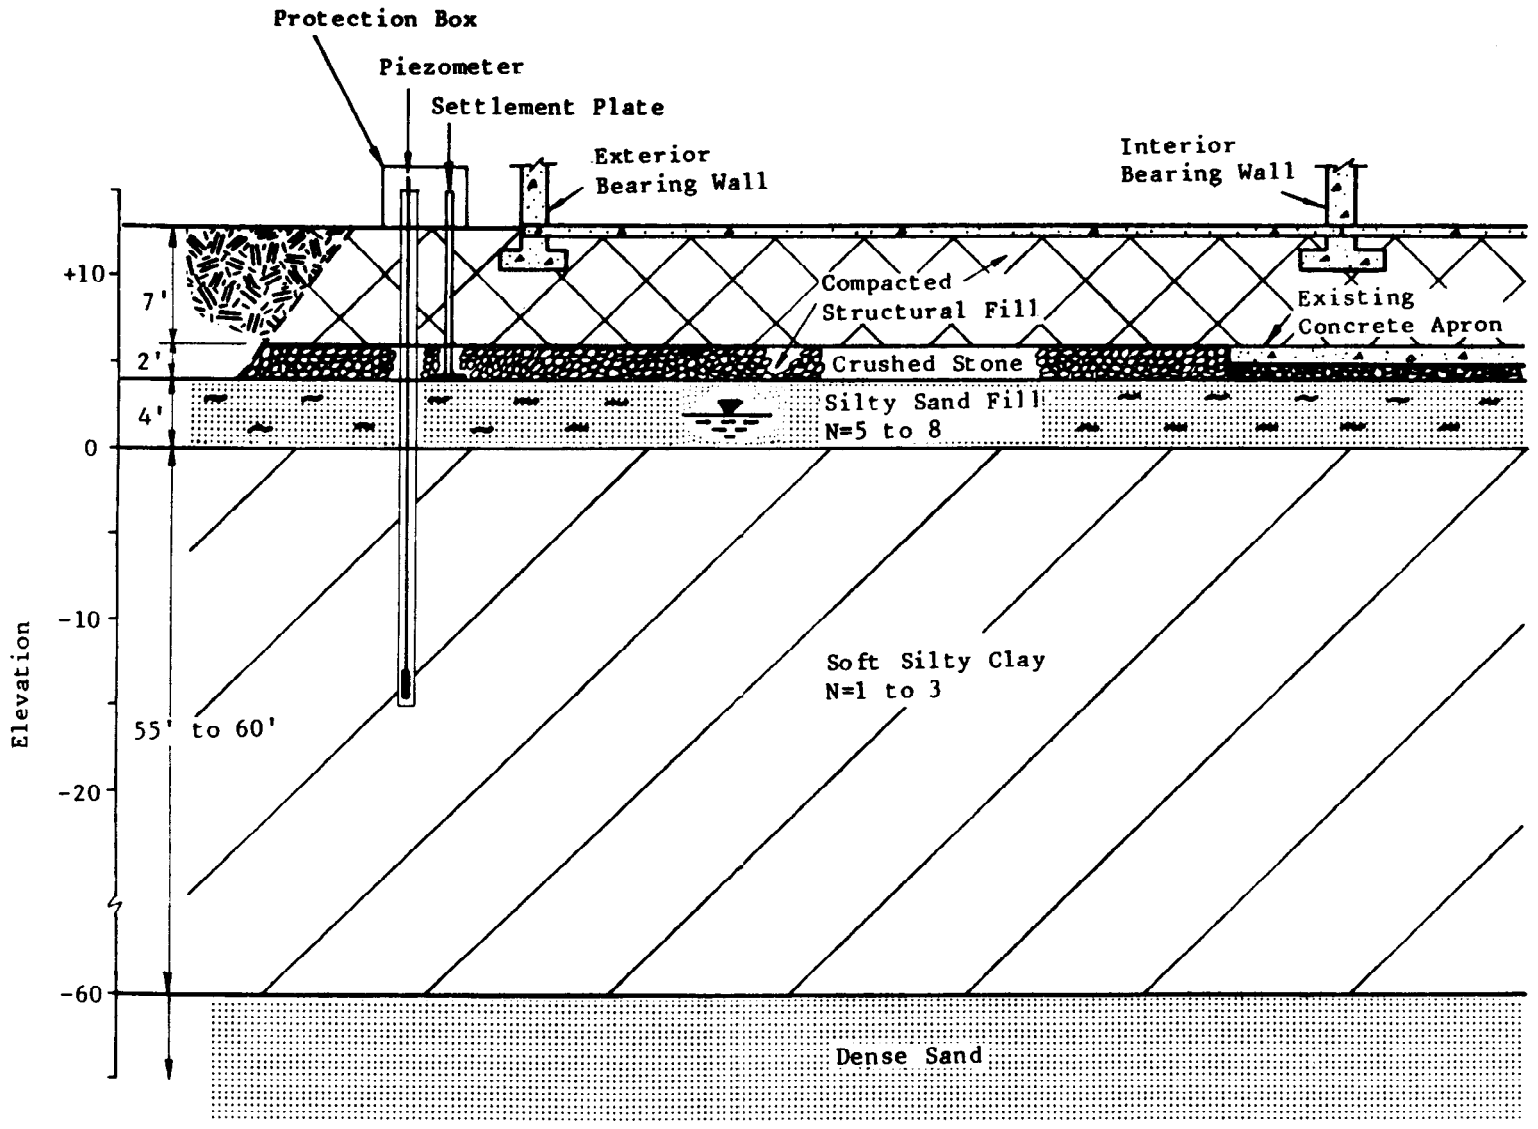
Fig. 1. Compacted fill was placed on a two feet thick layer of crushed stone. In the area where concrete apron existed, it was left in place to substitute for crushed stone base. Foundation soils are 4 feet of recent medium dense sand fill, which is under1ain by 55 to 60 feet (17 to 18 m) thick, highly compressible clay.

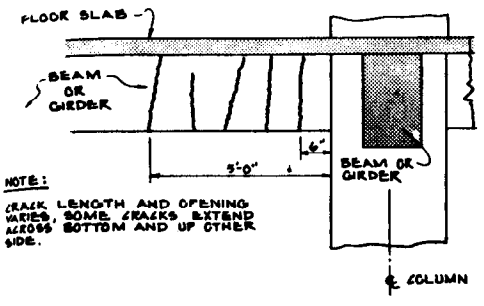
Fig. 1

Collection of Facts: Observation of the cracks indicated that the cracks on the beams were generated by reversal of stress - Fig. 1. The cracks in columns were caused by lack of pile support which resulted in the adjacent framing supporting the column instead of the column supporting the structure with the lower column and pile caps creating a tension load - Fig. 2.

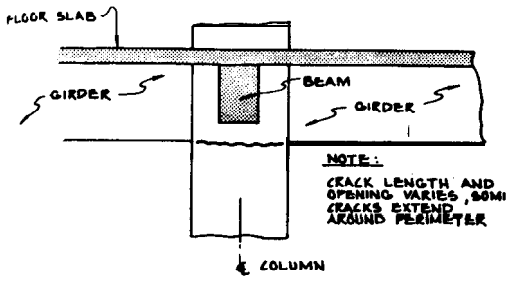
Fig. 2

Exploratory pits were opened to check the timber piles and concrete pile caps. The timber piles under the structural members which had experienced cracks were found deteriorated and in some cases the upper portion was completely decayed. After an extensive exploration at various locations of the piles, the problem area was isolated. A large diameter sewer pipe runs along the deteriorated piles. The leakage from and infiltration to the pipe was the apparent cause of the deterioration.

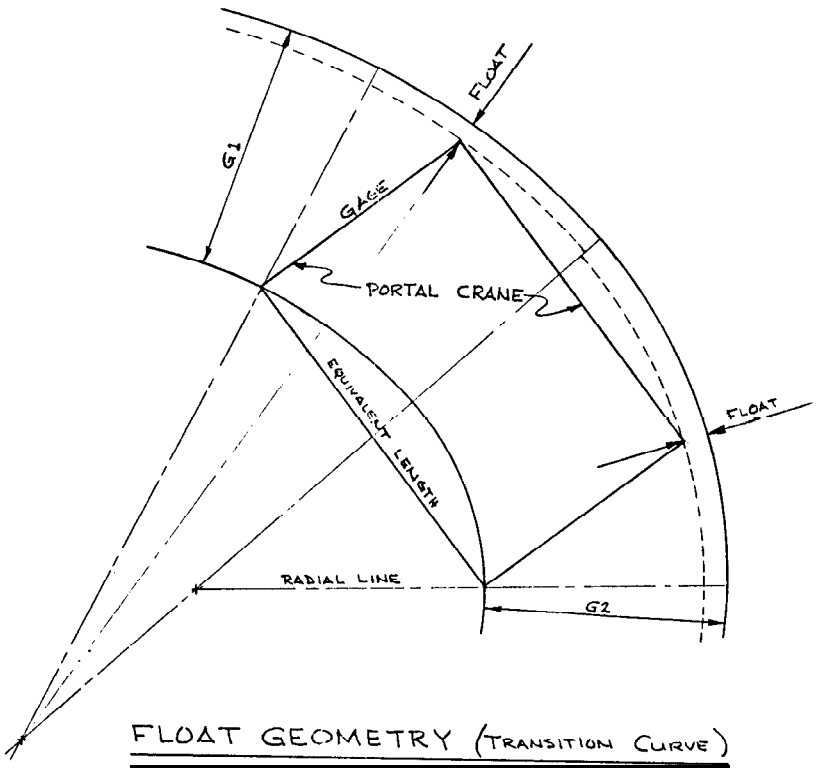
FIGURE 1

Collection of Facts: A west coast shipyard proposed that the float that provides a means for cranes to go around curves, designed on portal cranes, should be redesigned so they would operate by the available centrifugal force generated by the crane going around a curve. Float has lateral or sideways movement capability that is built into portal crane running gear. This lateral movement is necessary because the geometry of the rectangular crane frame on a curved track does not allow the corners of the crane to touch both rails (See Figure 1). This phenomenon occurs because the ends of the crane do not fall on a radial line.

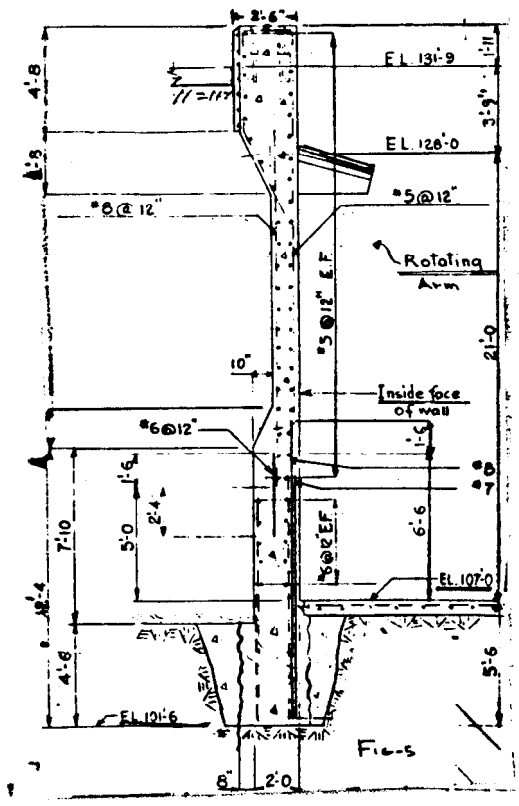
Symptoms: The structure under discussion is shown in Fig. 5. During the placement of concrete on the inside face of the wall and at elevations between 128'-0" and 131'-9", the forms failed outwards for a length of approximately 20 feet.

Collection of Facts: The experts review of the collapse concluded that the contractor had selected forms based on experience and intuition rather than on structural computations. The concrete was completely disintegrated and the reinforcing steel misplaced. The cost of replacement of the damaged part of the wall was approximately $500K.

Solution: Forms are very important elements of a structural system. As such, they must be analyzed and designed appropriately to withstand to predetermined loads and carry the stresses given by various codes. Therefore, they must be approved by a professional engineer as the rest of the structural system.
