Contract No. N62470-99-D-3251
High Antenna Tower System Inspection

Metallurgical Study
Corona Rings in the 1000' Guyed Tower
Grindavik, Iceland
Inspection Date: July 8-13, 2002

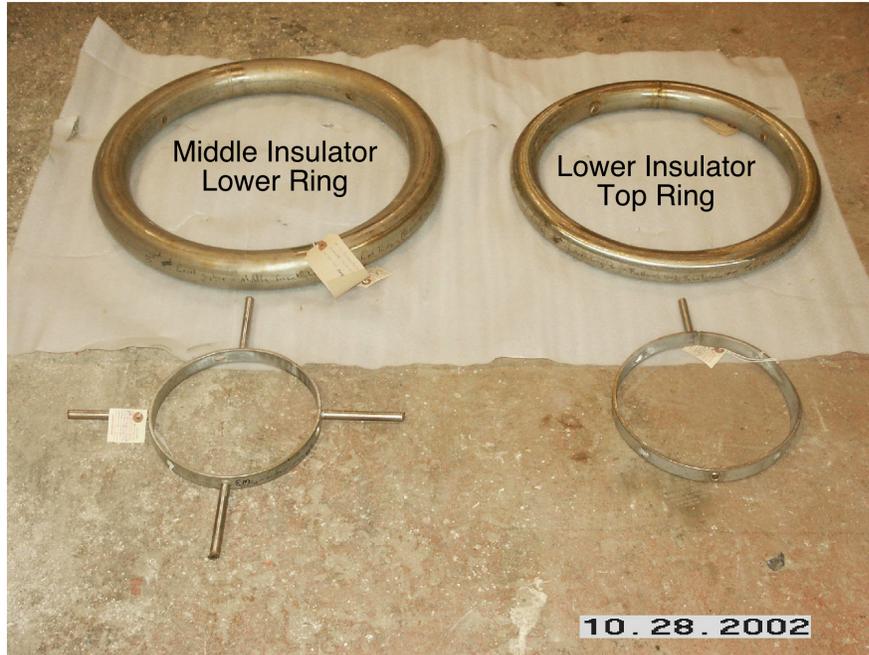
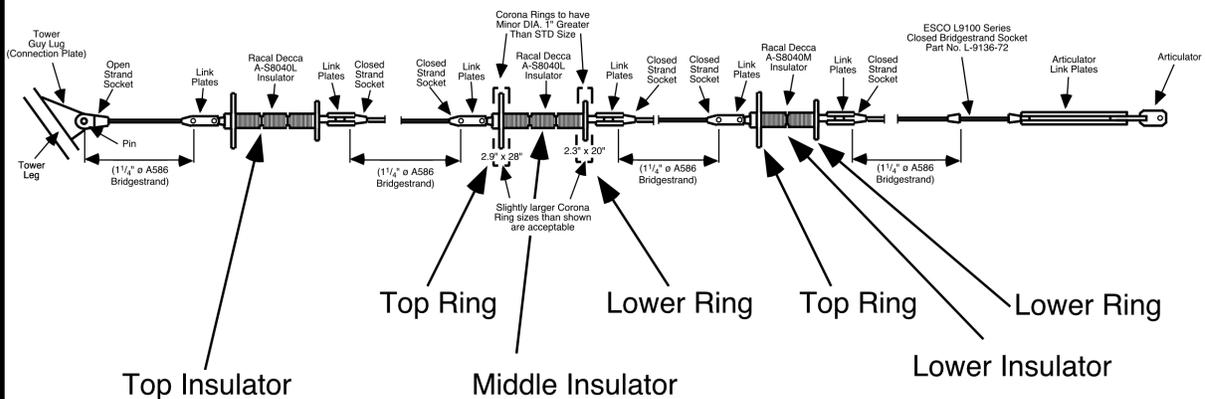
Sheet 3 of 3

Third Guy Level - Middle and Lower Insulator Separated Corona Rings

Upper Guy (Third Level Guy) Construction
